GEOMORPHIC ASSESSMENT REPORT
TETON CREEK
TETON COUNTY, IDAHO

August 22, 2017

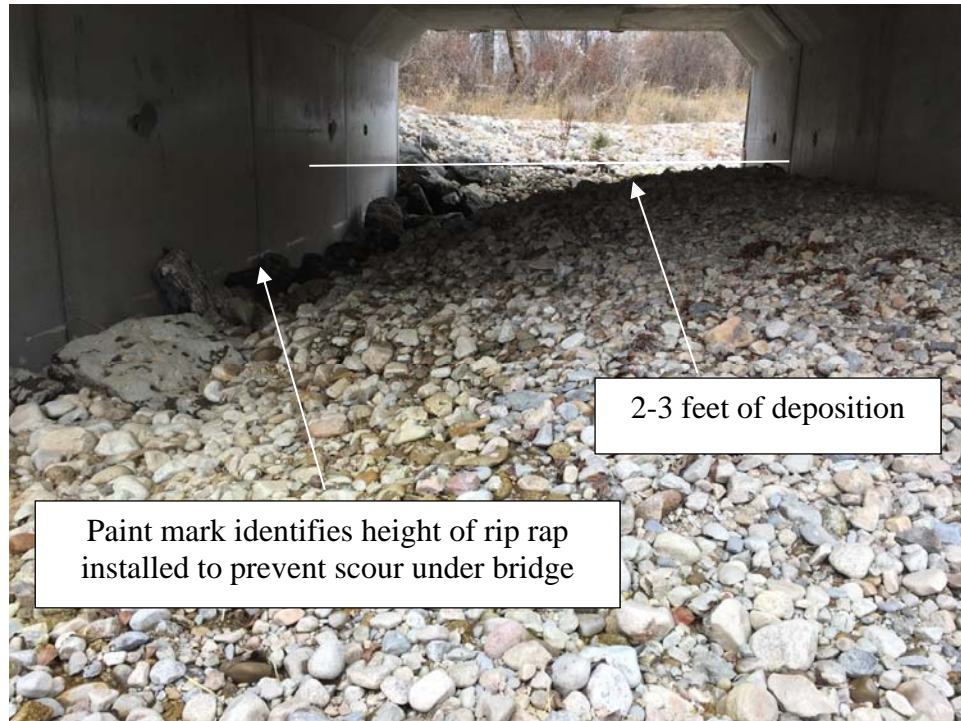
Localized deposition and channel aggradation are evident at the Cemetery Road Bridge (which is located at Station 0+00 ft in the Assessment Reach). Rock rip rap installed to prevent scour at the bridge location is evident under 2-3 feet of gravel deposition that has occurred at the location (Figure 3). Downstream of Cemetery Road Bridge, braided channels are separated by vegetated islands and complex large wood structure. Individual channels have relatively functional channel geometry with mature vegetation on the channel margins, and intact low flow (inner berm) channels and suitable geometry (Figure 4).

Figure 3. Photograph 1, deposition and channel aggradation at the Cemetery Road Bridge, Assessment Reach Station 0+00 ft.

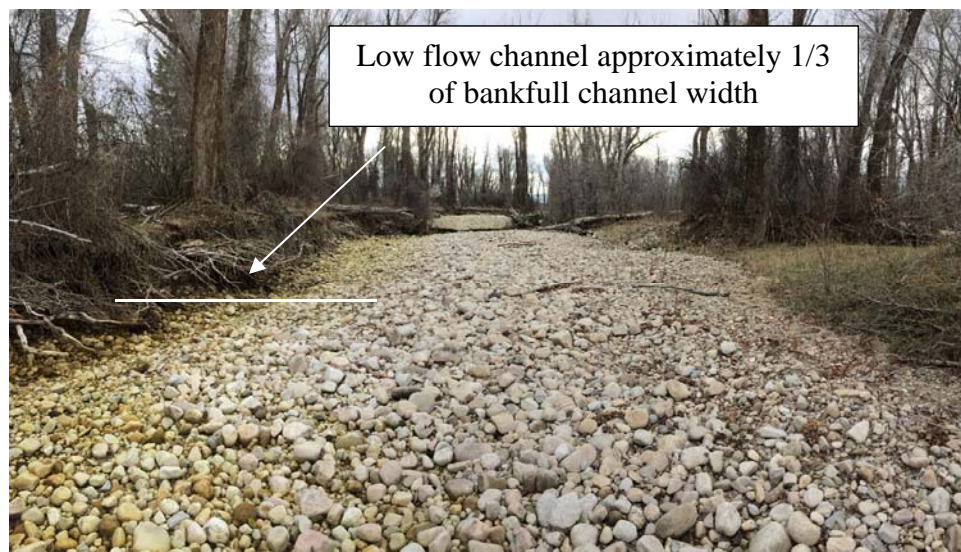
Figure 4. Photograph 2, relatively functional channel geometry with vegetated banks and low flow channel downstream of Cemetery Road Bridge at Station 2+00 ft.

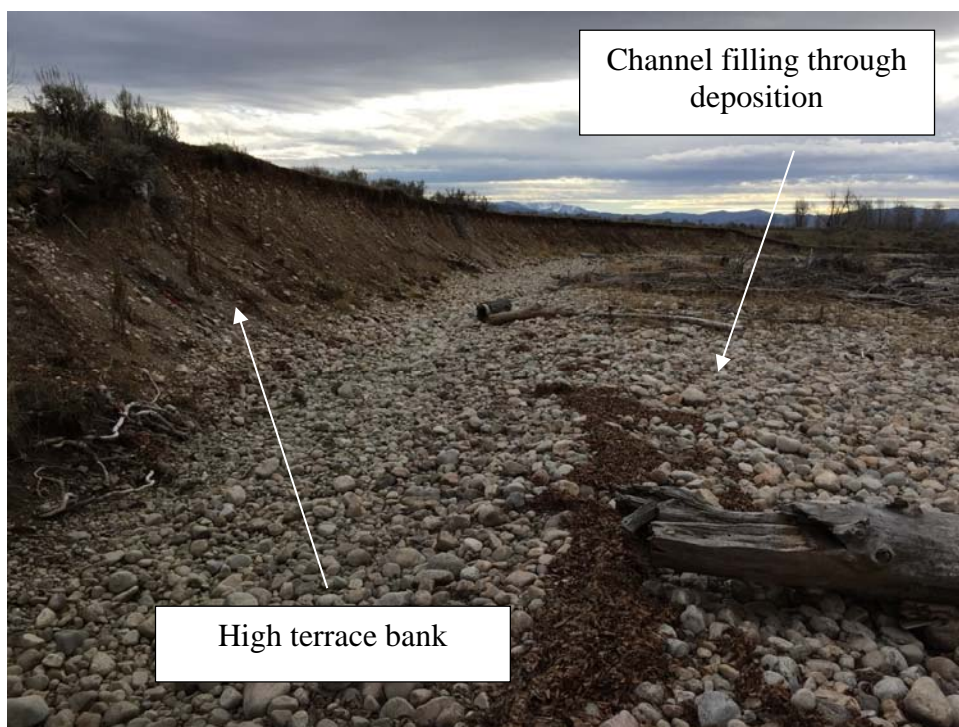
Widespread sedimentation and the formation erosive meander cutoff channels is evident from about station 7+00 ft downstream to station 18+00 ft (Figures 5 and 6).

Figure 5. Photograph 3, exposed vertical terrace bank and sedimentation, Station 10+00 ft.

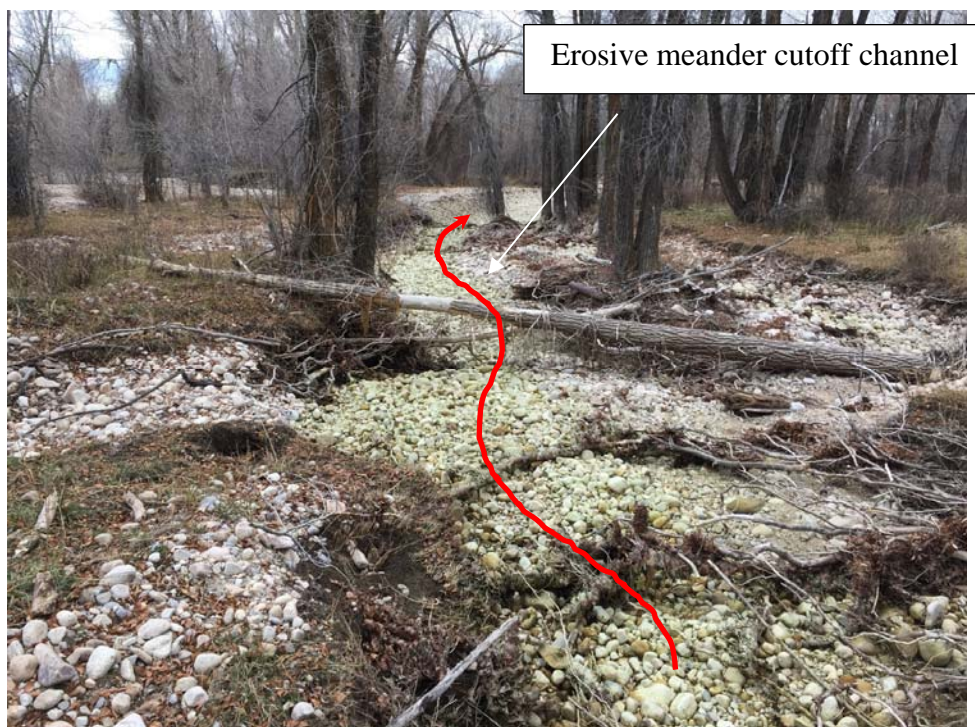
Figure 6. Photograph 4, newly formed erosive meander cutoff channel, Station 10+00 ft.

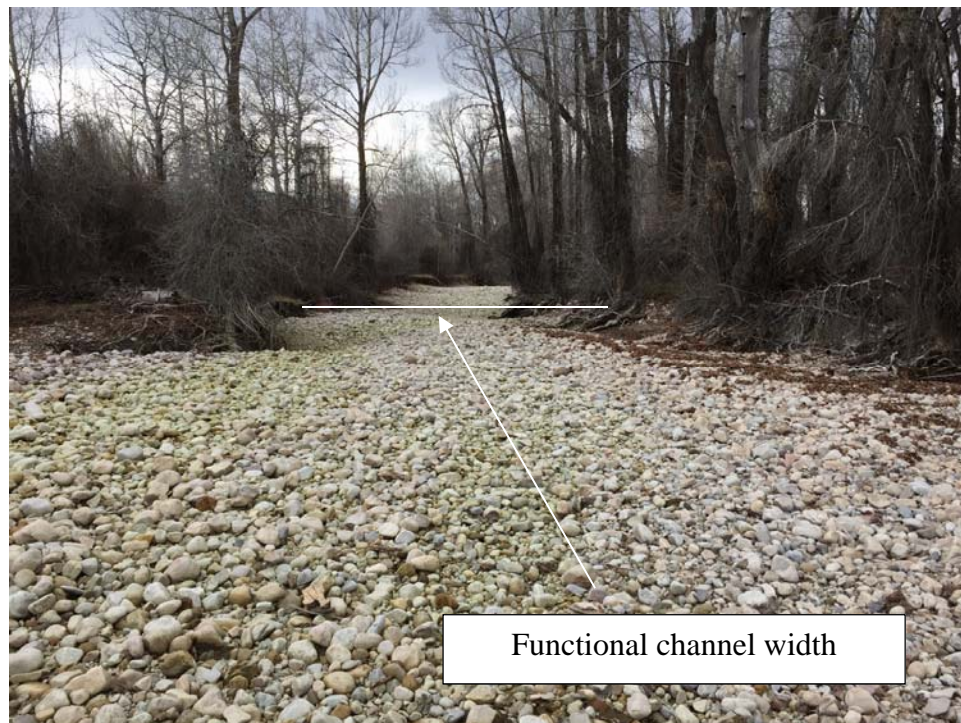
Figure 7. Photograph 5, relatively functional sub-reach with mature vegetation on the channel margins and defined low flow channel, Station 20+00 ft.

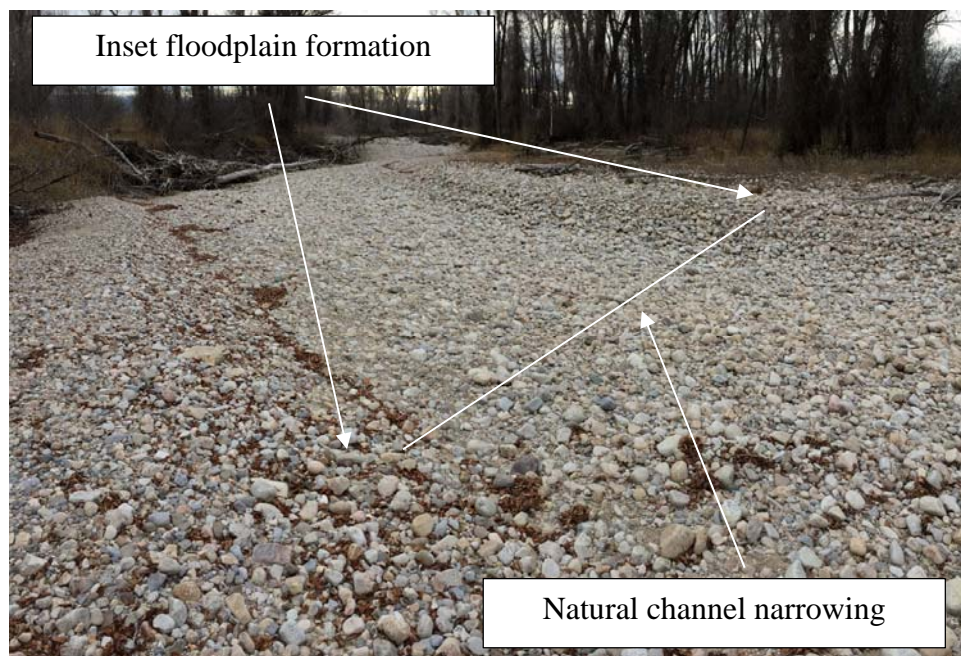
Figure 8. Photograph 6, area of natural channel narrowing through formation of inset floodplain benches, Station 34+00 ft.

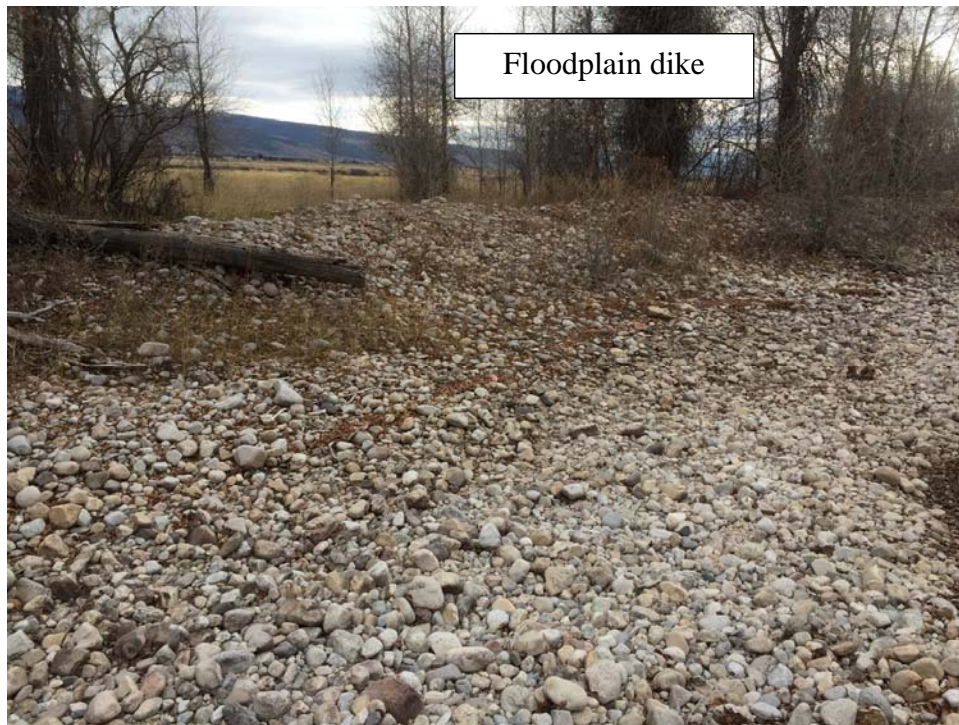
Levees and dikes constructed of sidecast and placed alluvium are evident along both river right and river left stream banks from about Station 38+00 ft to Station 64+00 ft (Figures 9 and 10). Floodplain dikes are generally constructed of coarse alluvium and have been colonized by woody vegetation.

Figure 9. Photograph 7, floodplain levee and diking on the river left bank, Station 38+00 ft.

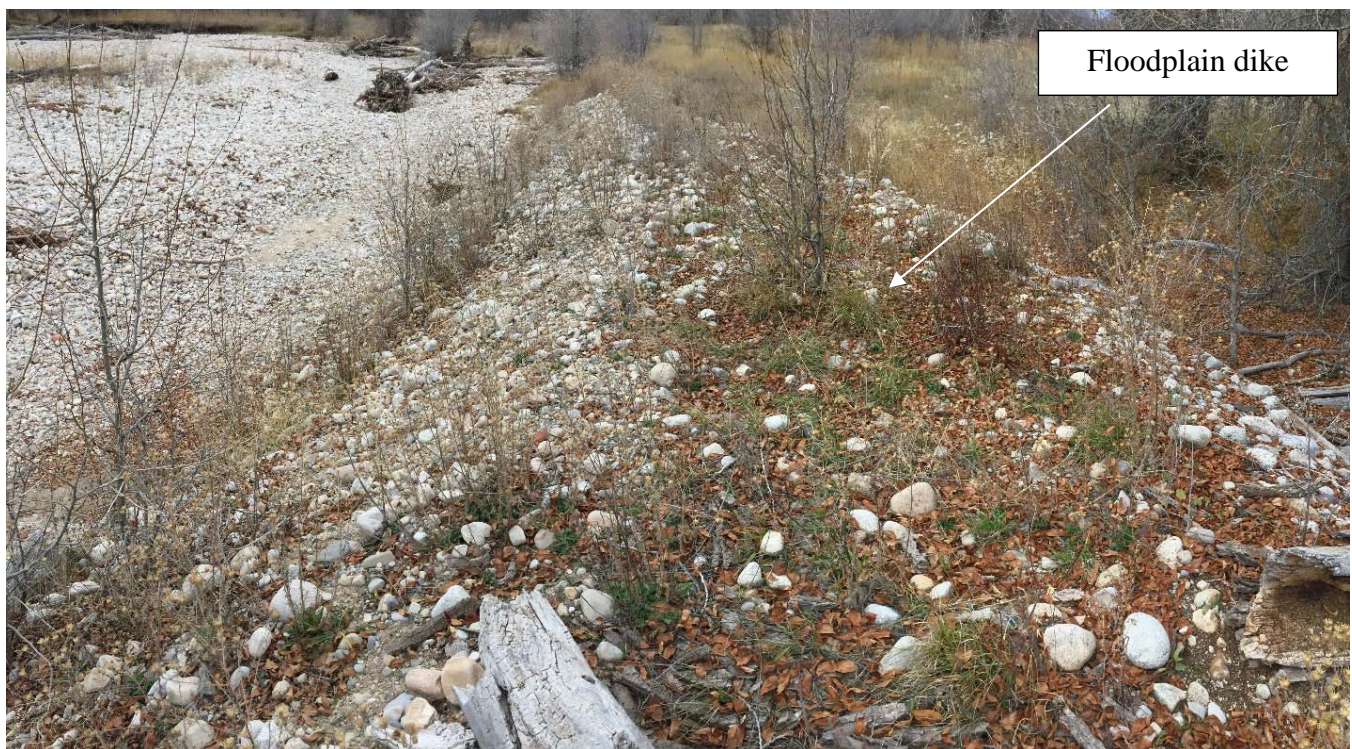
Figure 10. Photograph 8, floodplain levee and diking on the river right bank, Station 40+00 ft.

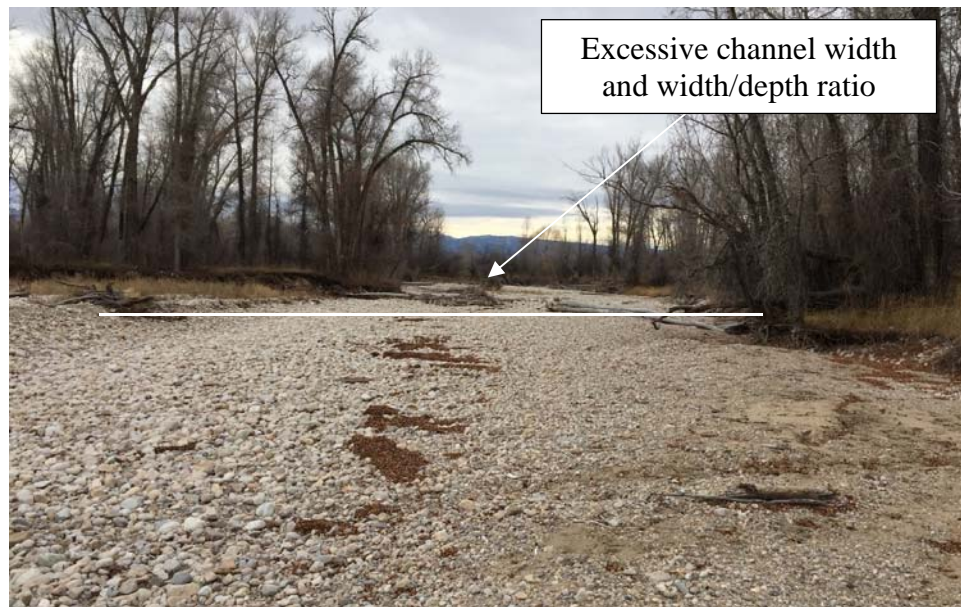
Sub-reaches with high width/depth ratio persist in areas where natural channel recovery is not occurring (Figure 11). Extensive bank armoring is in place from Station 62+00 ft downstream to Station 88+00 ft (Figure 12). At numerous locations where bank armoring has been installed, changes in channel form have resulted in localized deposition that has buried rip rap or changes flow dynamics proximate to the armoring.

Figure 11. Photograph 9, high width/depth ratio homogeneous channel, Station 47+00 ft.

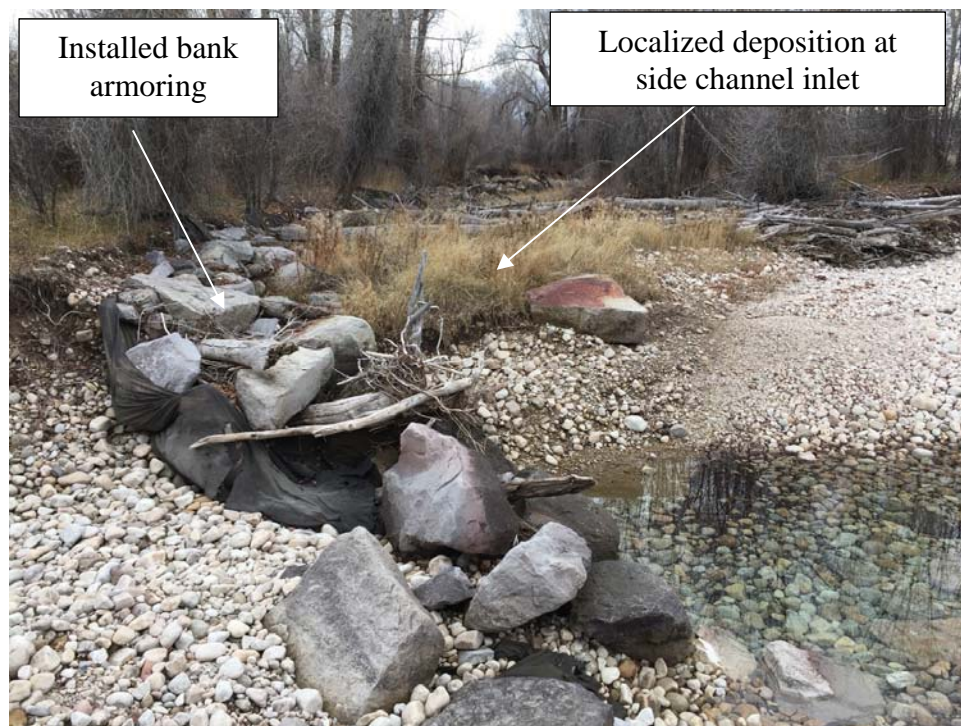
Figure 12. Photograph 10, bank armoring on the channel margin, with localized deposition that has filled the inlet to a side channel, Station 52+00 ft.

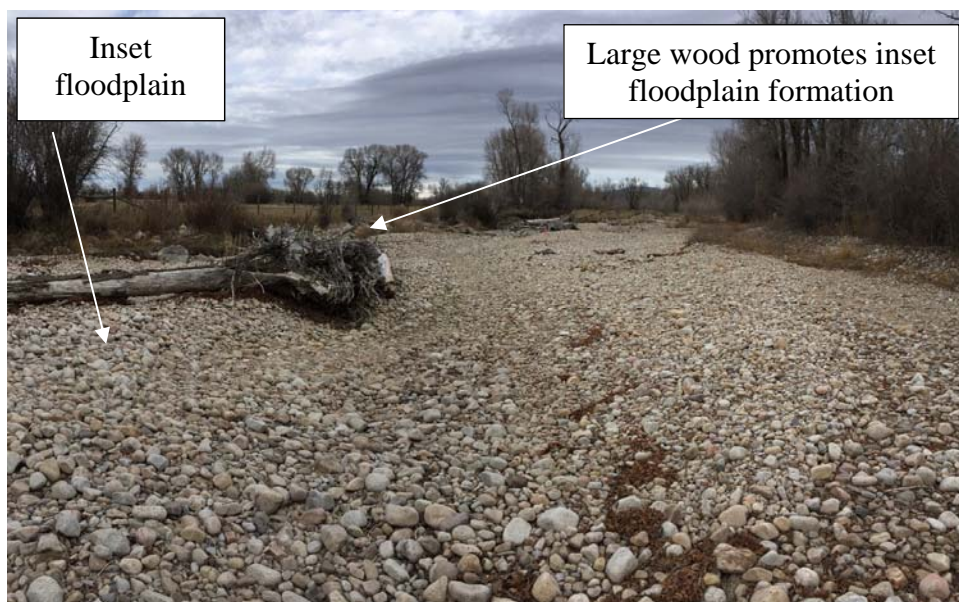
Widespread sedimentation in the form of point bar enlargement and inset floodplain bench creation are evident from Station 24+00 ft downstream to Station 67+00 ft (Figure 13). Bank armoring is prevalent from about Station 62+00 ft downstream to Station 88+00 ft. At some locations rip rap has been installed on opposing stream banks, such that river confinement promotes increased flow velocities and the transfer of erosive potential to downstream sub-reaches (Figure 14).

Figure 13. Photograph 11, wood debris promotes natural channel recovery through floodplain bench formation and channel narrowing, Station 57+00 ft.

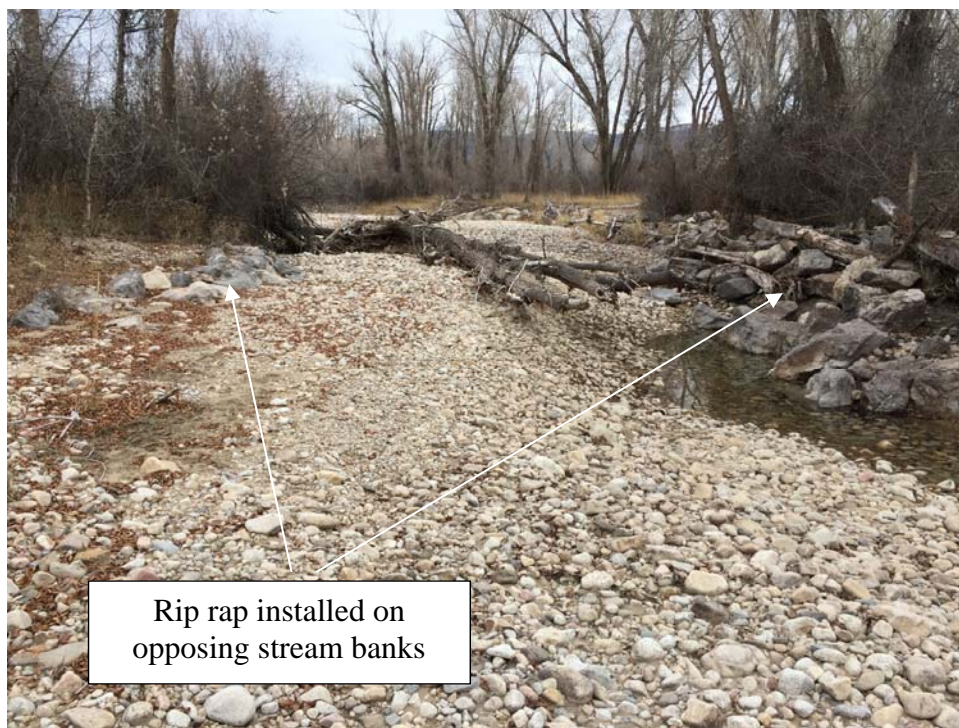
Figure 14. Photograph 12, bank armoring through rip rap installation on opposing stream banks, Station 59+00 ft.

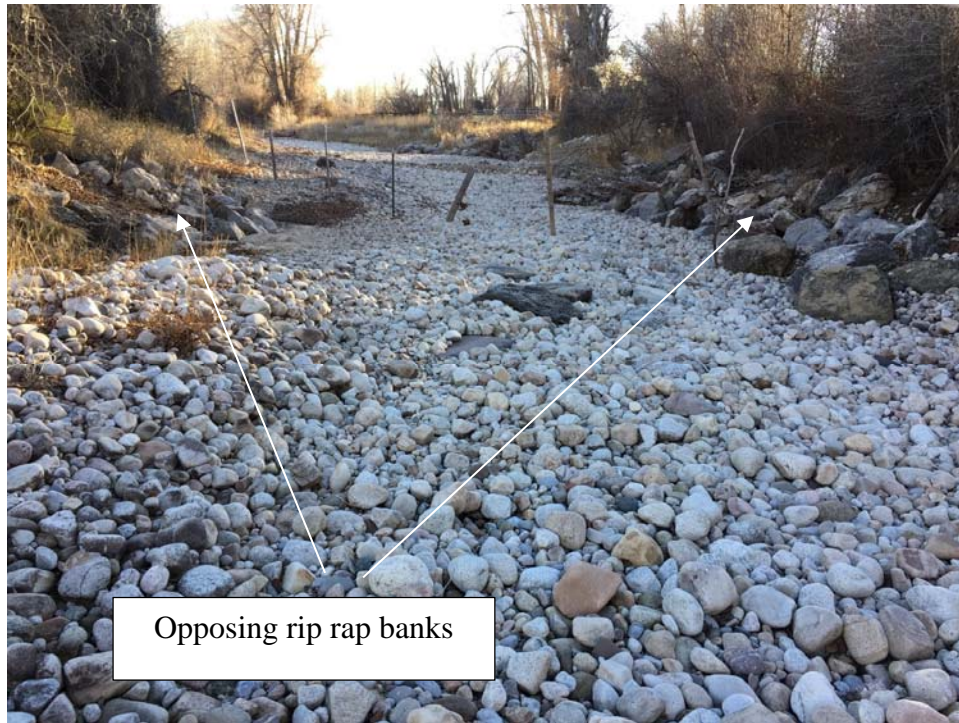
Bank armoring is prevalent from about Station 62+00 ft downstream to Station 88+00 ft (Figure 15). The channel is relatively straight, homogeneous (lacking a low flow channel, or inner berm), and has high width/depth ratio from about Station 65+00 ft to 76+00 ft (Figure 16).

Figure 15. Photograph 13, bank armoring through rip rap installation on opposing stream banks, Station 64+00 ft.

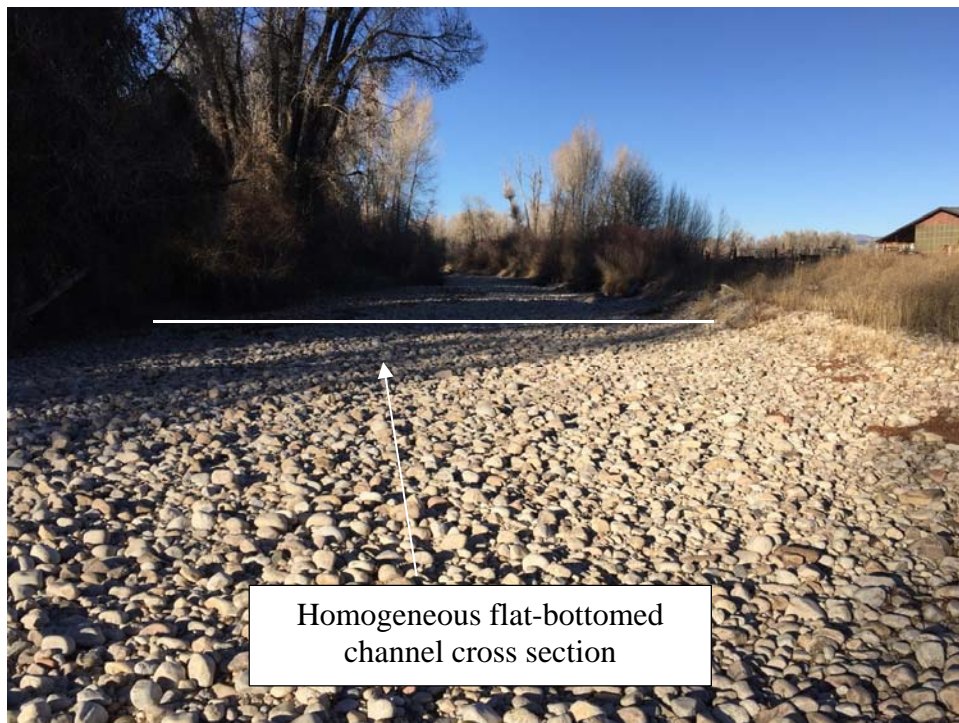
Figure 16. Photograph 14, high width/depth ratio homogeneous channel, Station 73+00 ft.

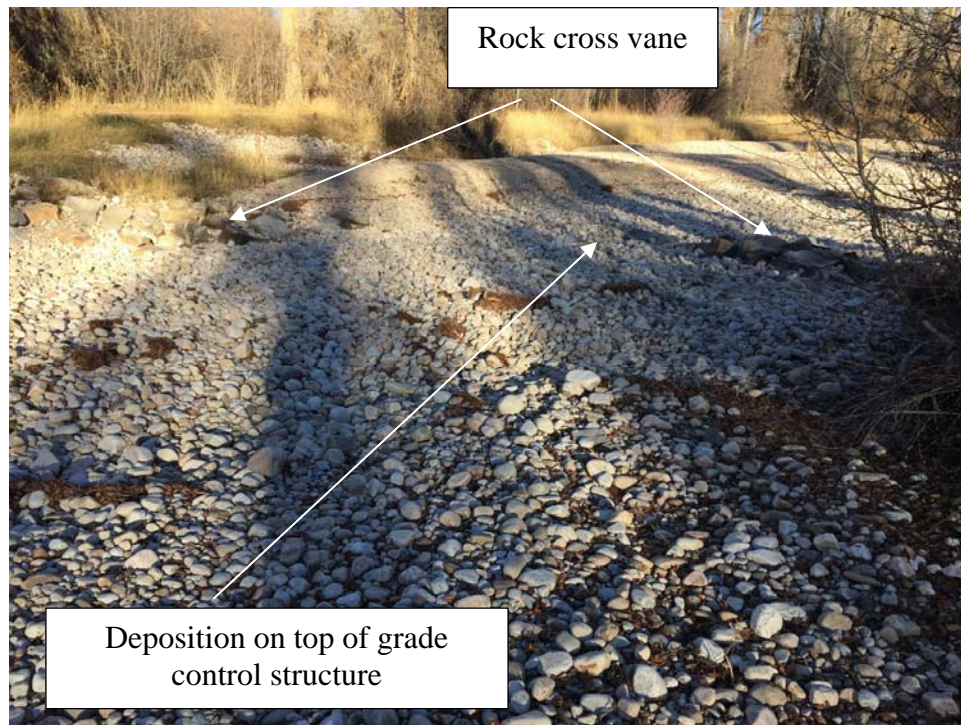
Widespread deposition and channel aggradation are evident from about Station 77+00 ft downstream to 114+00 ft. In some areas deposition has covered rock structures installed for grade control (Figure 17). In other areas, point bar enlargement and formation is achieving sediment storage and promoting lateral channel migration and increased sinuosity (Figure 18).

Figure 17. Photograph 15, aggradation on top of installed rock cross vane grade control structure, Station 78+00 ft.

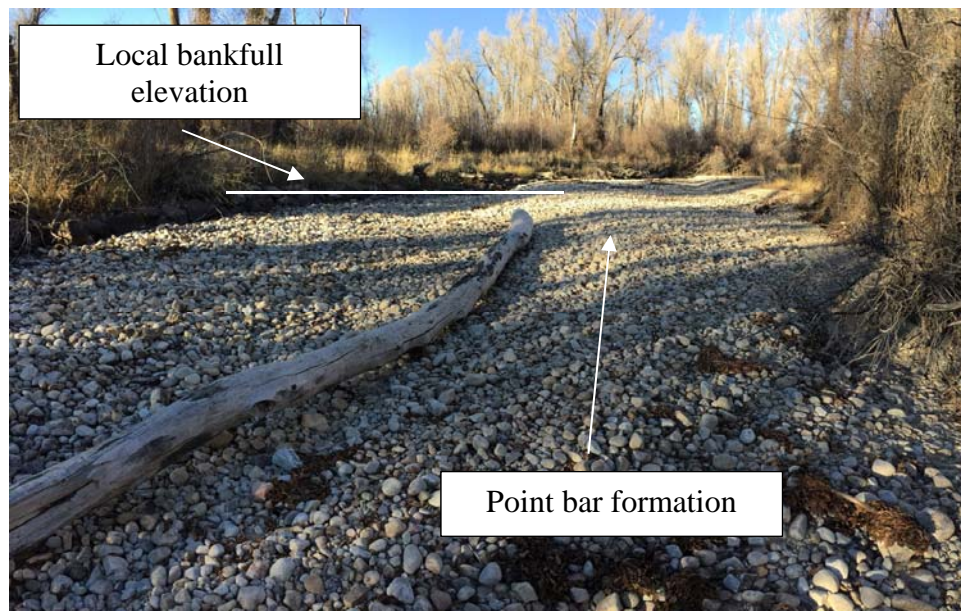
Figure 18. Photograph 16, sediment deposition and bar formation to the local bankfull/floodplain elevation, Station 79+00 ft.

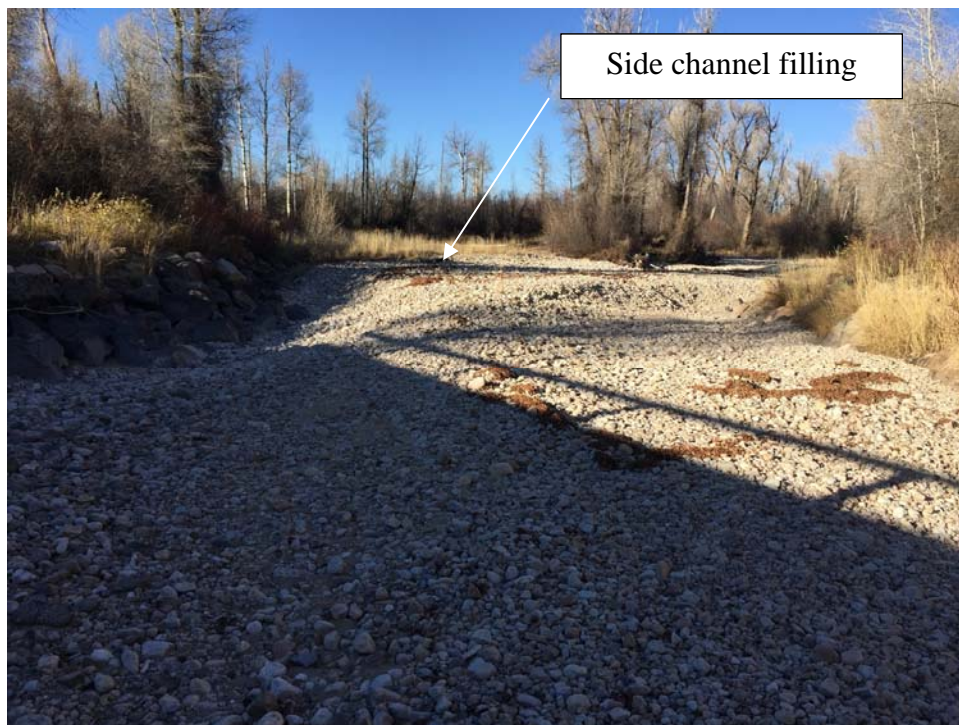
Widespread deposition and channel aggradation are evident from about Station 77+00 ft downstream to 114+00 ft. Point bar enlargement and filling of side channels are prominent (Figure 19). Channel aggradation and pool filling are severe proximate to the Creekside Meadows Bridge (Figure 20).

Figure 19. Photograph 17, high width/depth ratio channel and widespread sedimentation, Station 85+00 ft.

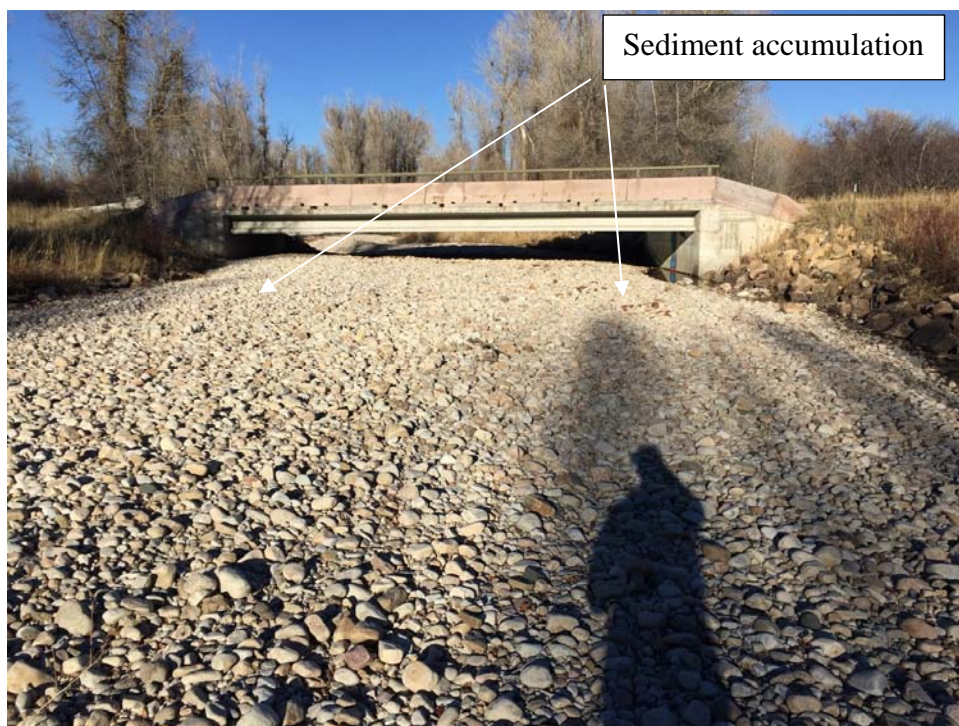
Figure 20. Photograph 18, high width/depth ratio channel and sedimentation/aggradation at Creekside Meadows Bridge, Station 87+00 ft.

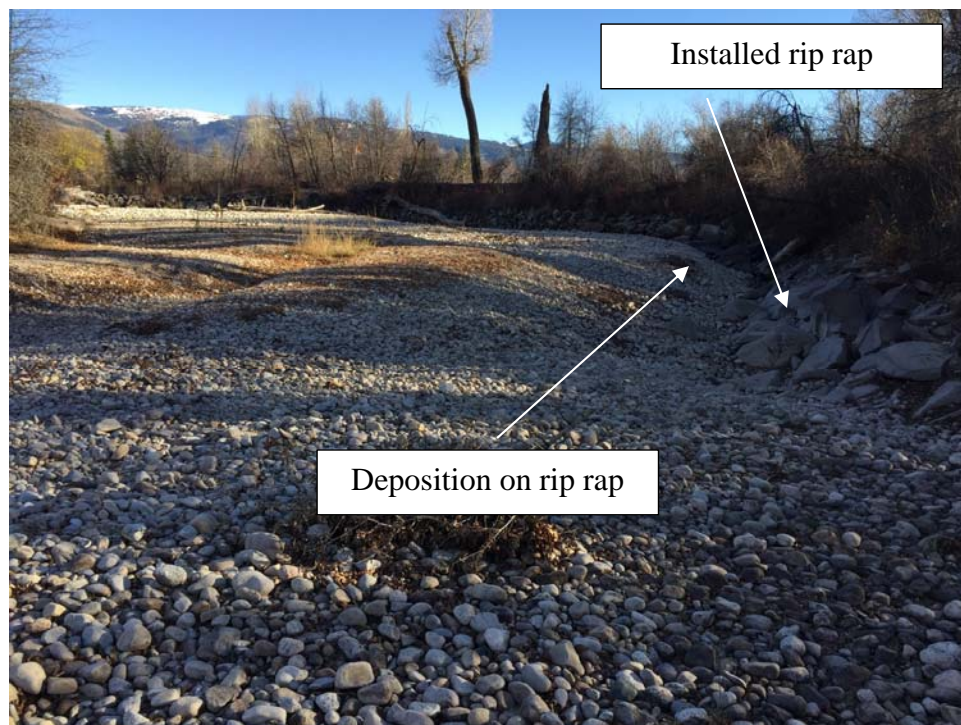
Severe aggradation, coupled with point bar enlargement and pool filling, has resulted in deposition that now covers rock rip rap previously installed to protect stream banks from erosion (Figures 21 and 22).

Figure 21. Photograph 19, sedimentation, pool filling, and channel aggradation covering installed rock rip rap, Station 89+00 ft.

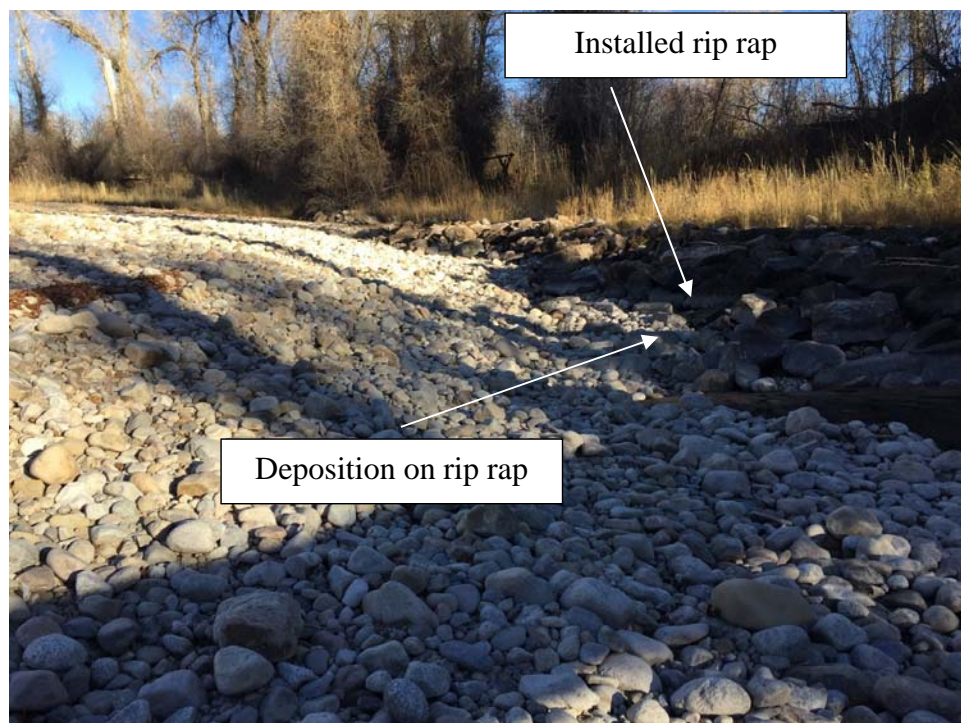
Figure 22. Photograph 20, sedimentation, pool filling, and channel aggradation covering installed rock rip rap, Station 93+00 ft.

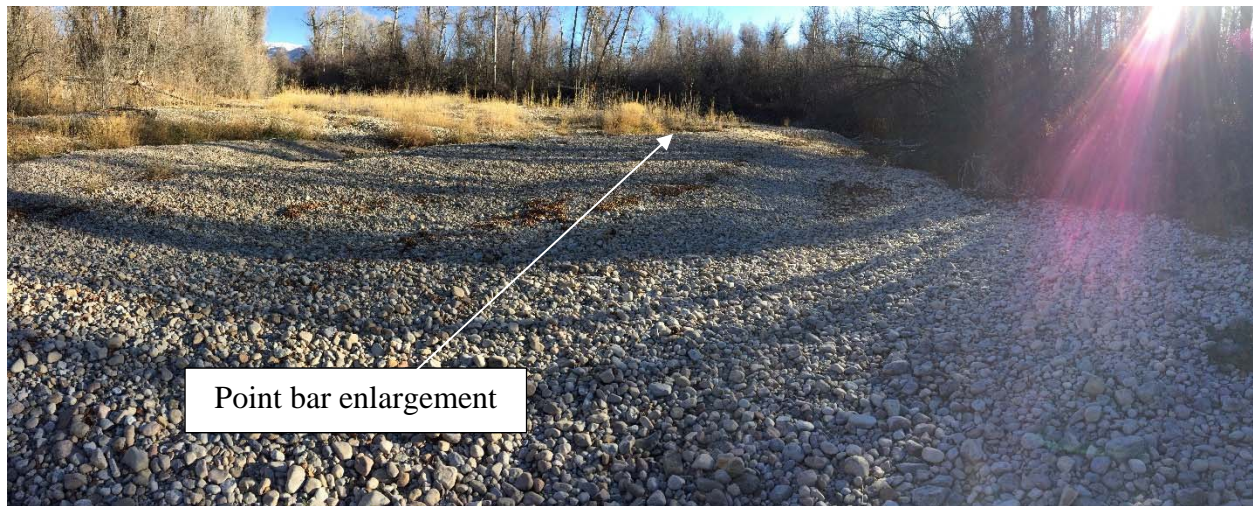
Point bar enlargement and sedimentation are typical of the sub-reach located in Creekside Meadows upstream of the Highway 33 Bridge (Figure 23). Point bar enlargement and widespread sedimentation promote increased sinuosity and bank erosion on the outside of meanders. (Figure 24).

Figure 23. Photograph 21, rapid bar formation, sediment storage, herbaceous vegetation colonization, and lateral channel migration, Station 101+00 ft.

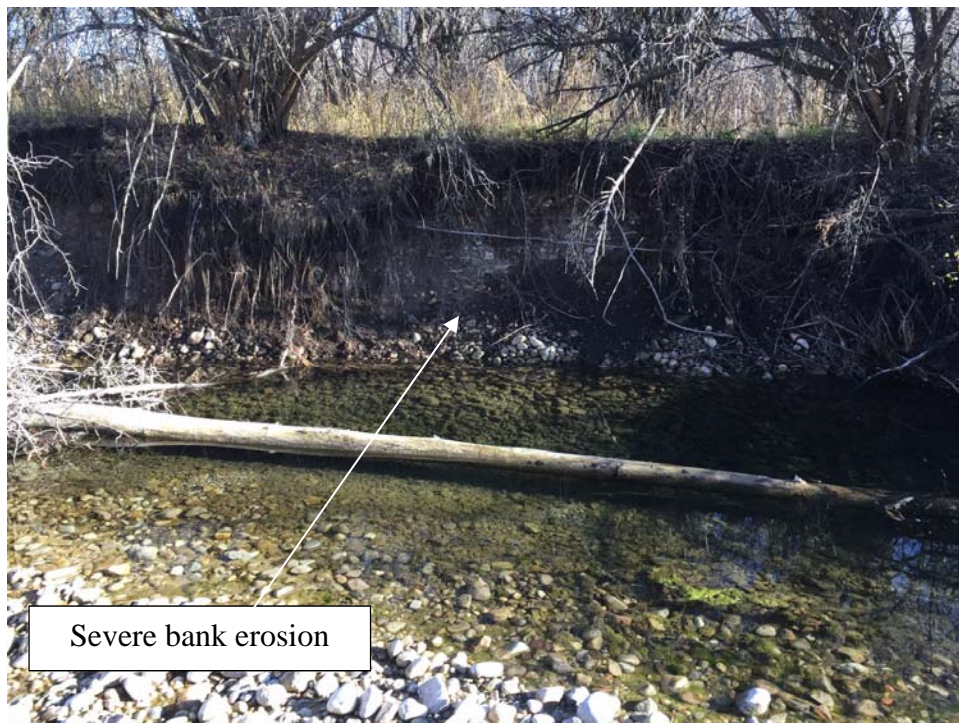
Figure 24. Photograph 22, sedimentation and point bar enlargement promote bank erosion at the outside of meanders, Station 109+00 ft.

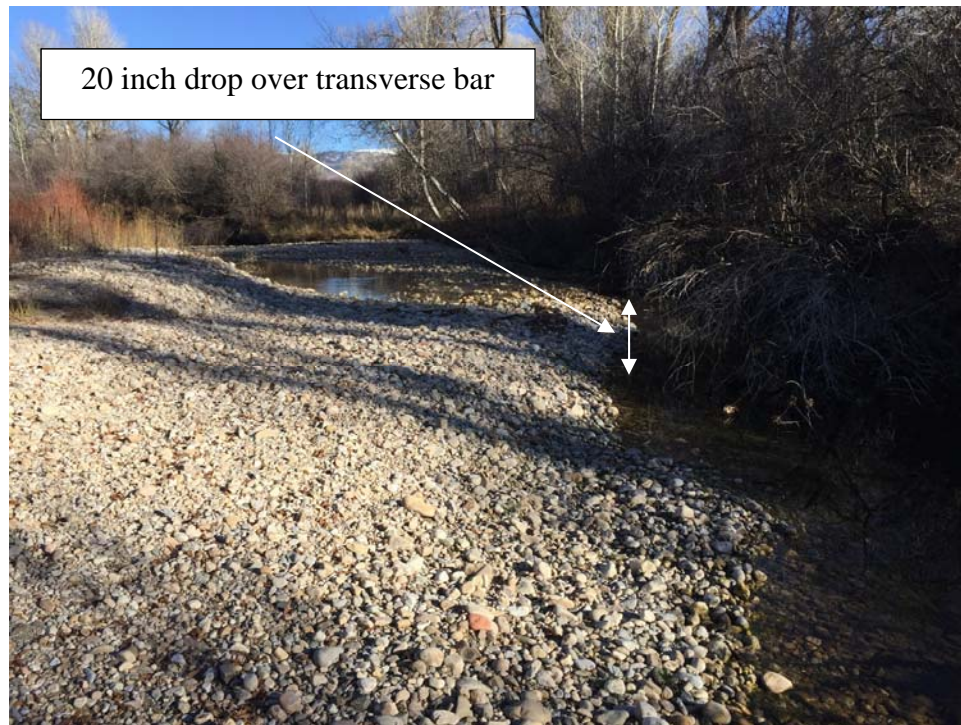
Near the downstream end of prominent aggradation in Creekside Meadows, individual transverse bars demonstrate high local gradient (Figure 25). Channel aggradation and sediment deposition are evident in the sub-reach of Teton Creek located upstream of the Highway 33 Bridge (Figure 26).

Figure 25. Photograph 23, transverse bar with 20 inches of local gradient, Station 111+00 ft.

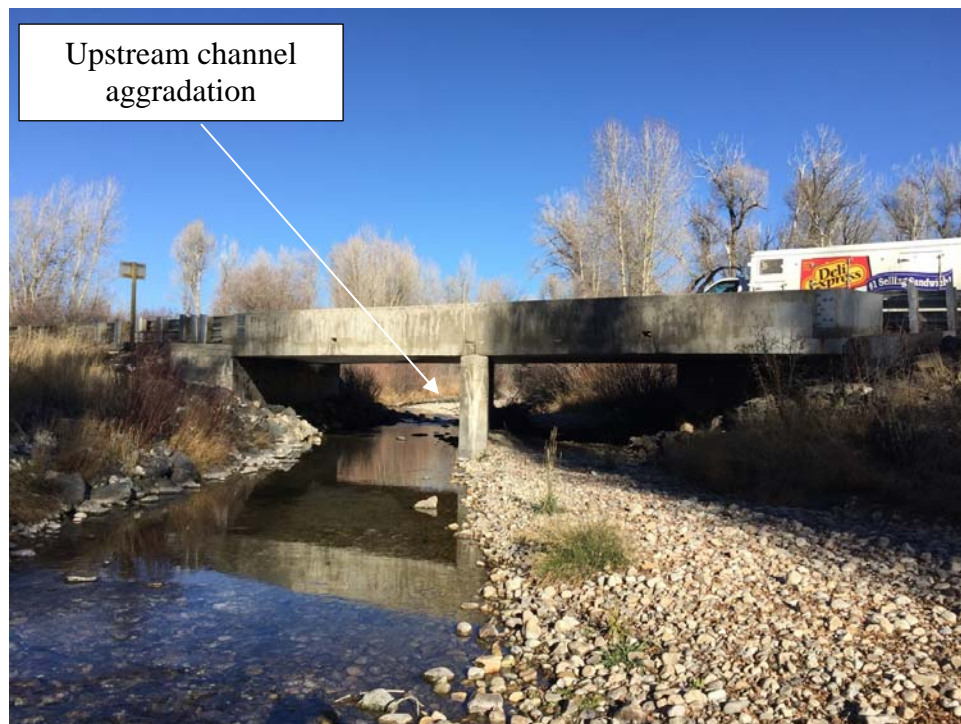
Figure 26. Photograph 24, deposition in river left bay of Highway 33 Bridge, Station 115+00 ft.

The reach of Teton Creek located adjacent to the Highway 33 Bridge (approximate Station 115+00 ft) demonstrates elevated bankfull flow velocity, shear stress, stream power, and sediment transport competence. The elimination of floodplain conveyance by the bridge structure results in the convergence and confinement of peak flows within the primary channel. This segment of Teton Creek is an area of concern because backwater conditions maintained by the bridge during peak flow events adversely impact the upstream impaired reach of creek through Creekside Meadows by promoting aggradation and lateral migration while increasing avulsion potential. Restoration efforts in this reach should explore opportunities to increase floodplain conveyance through installation of culverts at the bankfull elevation adjacent to the highway and pathway bridges, or through installation of longer bridges that span an inset floodplain of sufficient width to reduce backwater effects during peak flow events.

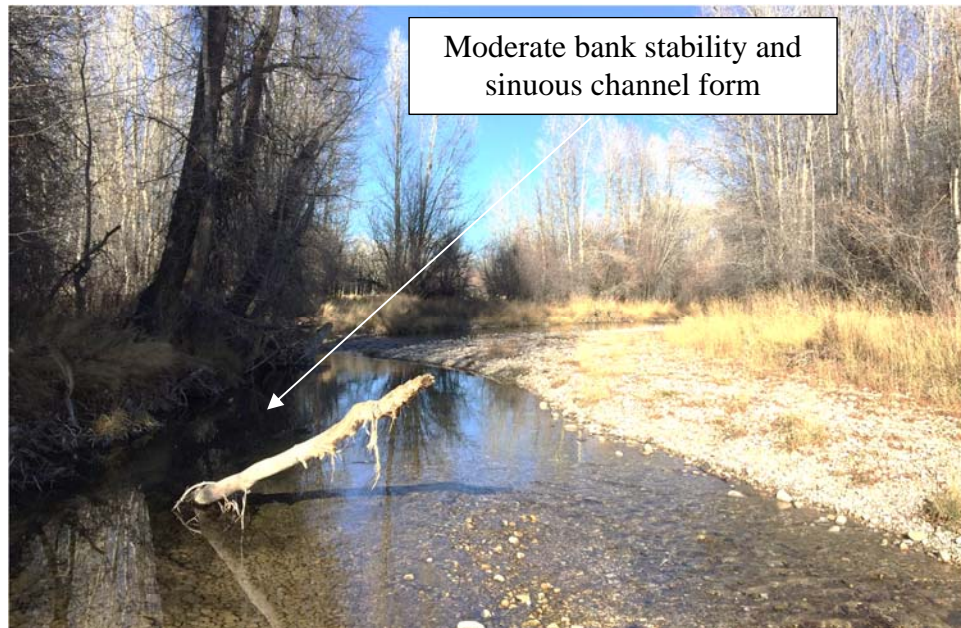
Below the Highway 33 Bridge there is a short sediment starved reach that has robust riparian vegetation and stable banks. About 500 ft downstream of the Bridge, the channel regains a sinuous meandering channel form characterized with low bank height and moderate bank stability (Figure 27). From Station 124+00 ft downstream to Station 129+00 ft, severe aggradation is evident. A large debris jam precludes conveyance of instream flows within the historic channel alignment, bank heights are nominal, and instream flows escape the channel and are conveyed across the floodplain even during base flow levels (Figure 28).

Figure 27. Photograph 25, functional meandering single thread channel form downstream of Highway 33 Bridge, Station 121+00 ft.

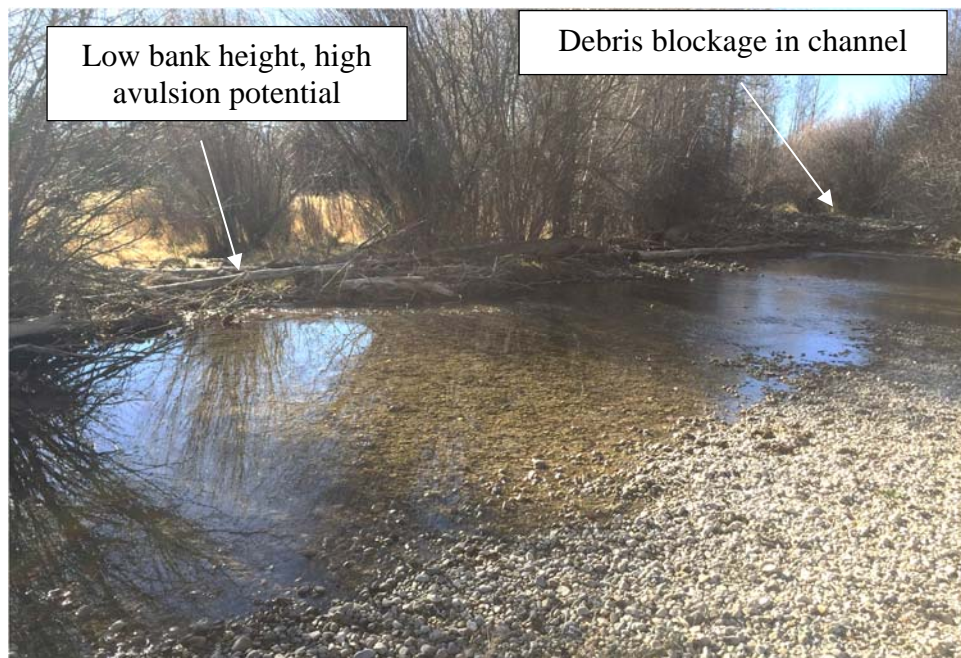
Figure 28. Photograph 26, channel blockage debris jam, widespread aggradation, and high avulsion potential, Station 128+00 ft.

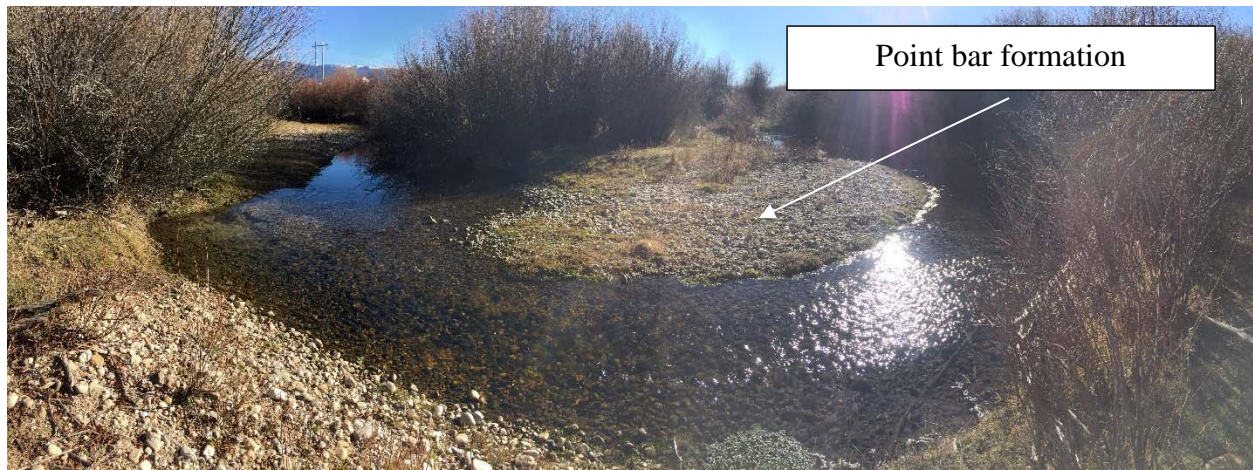
Floodplain conveyance paths generally converge at about Station 139+00 ft to form a southern channel of Teton Creek that has a sinuous single channel form with low bank height and point bar formations (Figure 29). The northern channel of Teton Creek, which maintains a separate alignment from the southern historic channel, also has a sinuous single channel form and demonstrates point bar formation and bank erosion at the outside of meanders (Figure 30).

Figure 29. Photograph 27, typical highly sinuous meandering channel form with point bar formation and low bank height near downstream end of Assessment Reach, Station 143+00 ft.

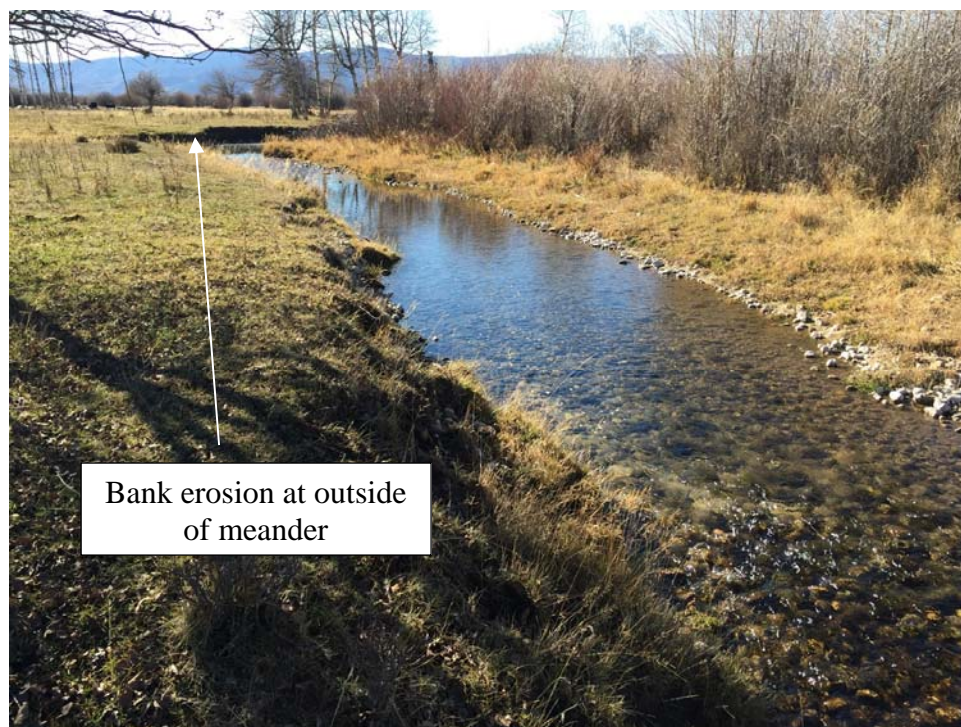
Figure 30. Photograph 28, typical highly sinuous meandering channel form with low bank height and ongoing lateral channel migration, Station 143+00 ft.

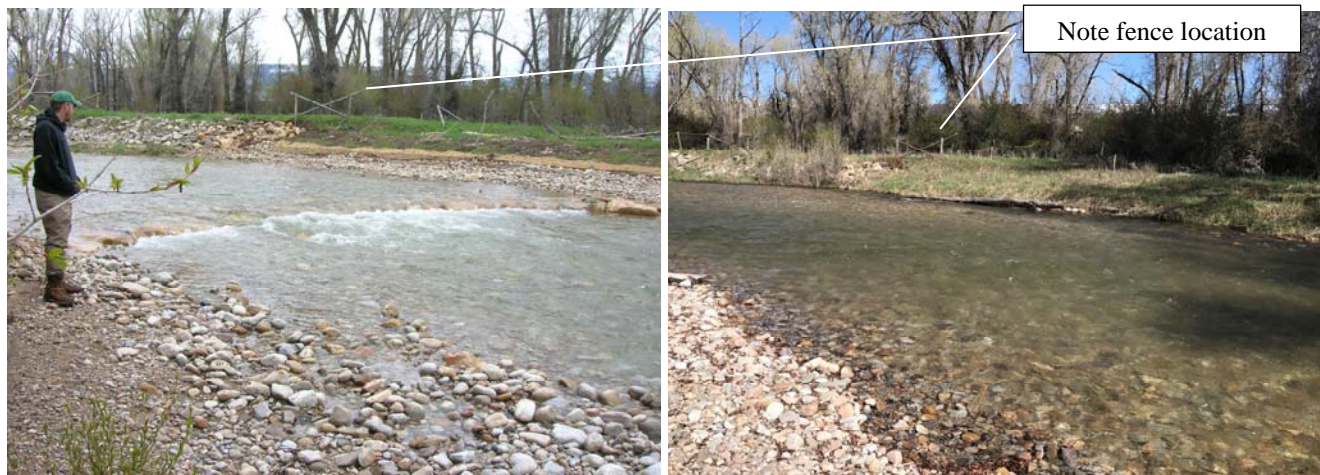
Figure 62. Photographic documentation of conditions within Creekside Meadows in 2008 (top) and 2017 (bottom).
