Teton Creek Restoration

Project highlights from 2006-present

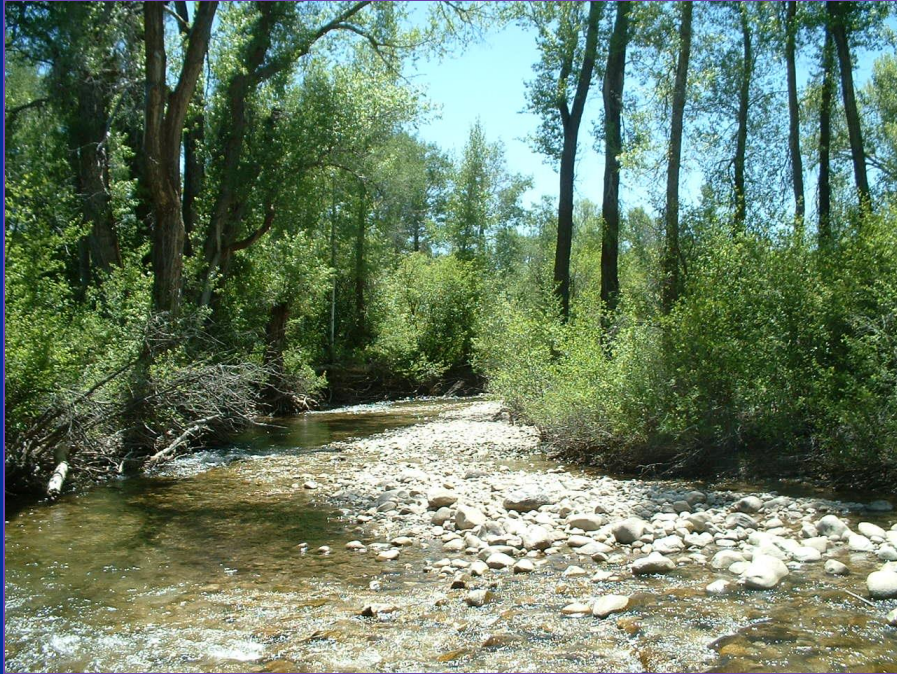
Reference Reach under
Natural Conditions

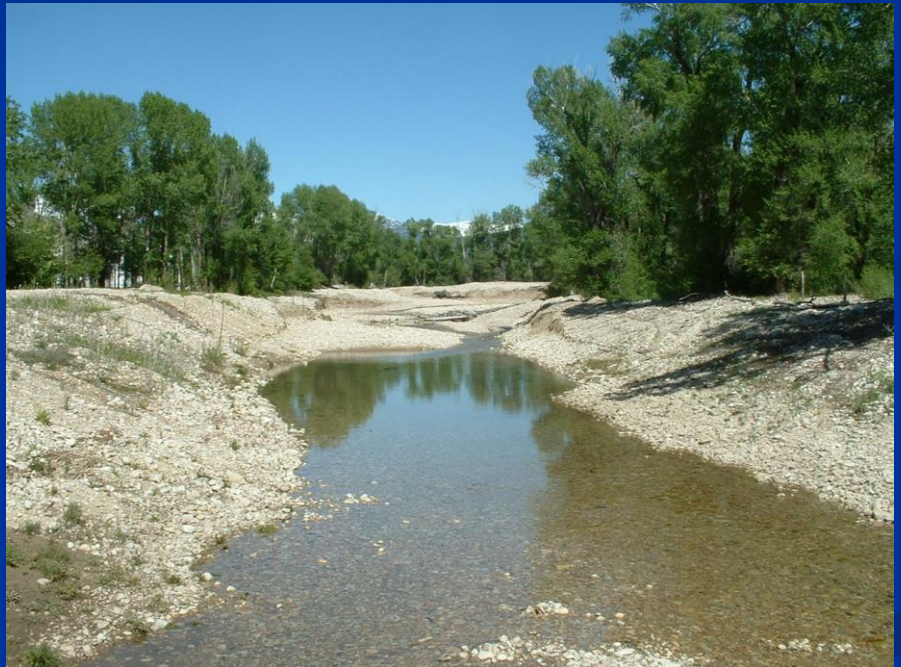
Landowner built levees and dredged nearly 1 mile of channel so he could develop the floodplain

180,000 tons of sediment displaced by
dredging most of which washed down
stream!

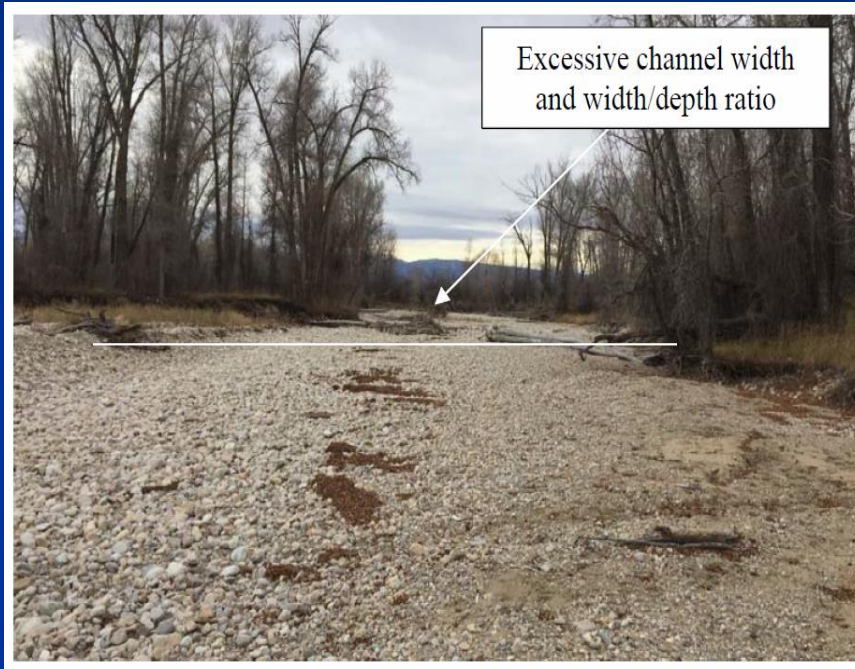
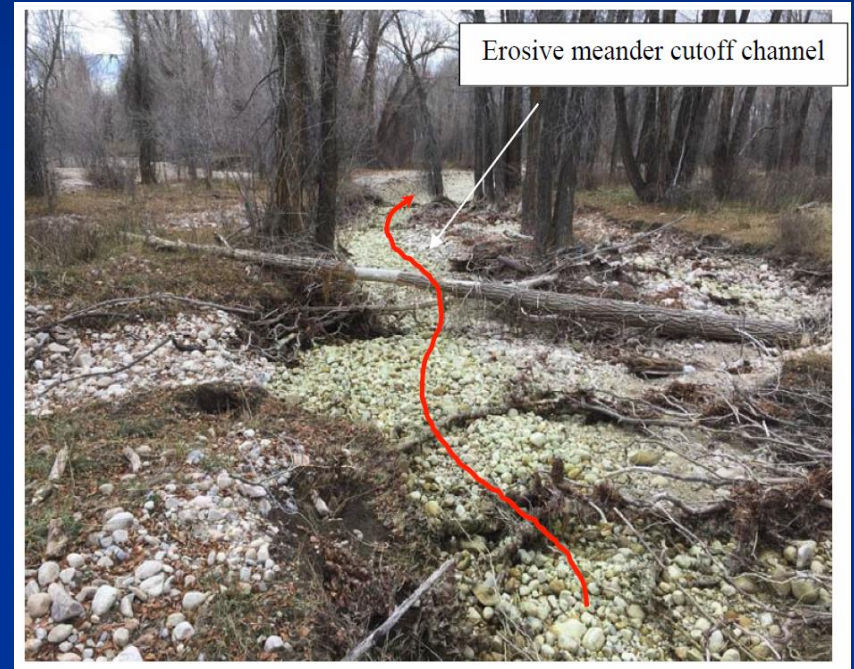
Stream Channel Impacts Assessed

“Over wide” and shallow channel , with no “path” or natural containment of flows, so water has to find a new erosive path—a natural process, but it puts existing property, homes, and infrastructure at-risk.

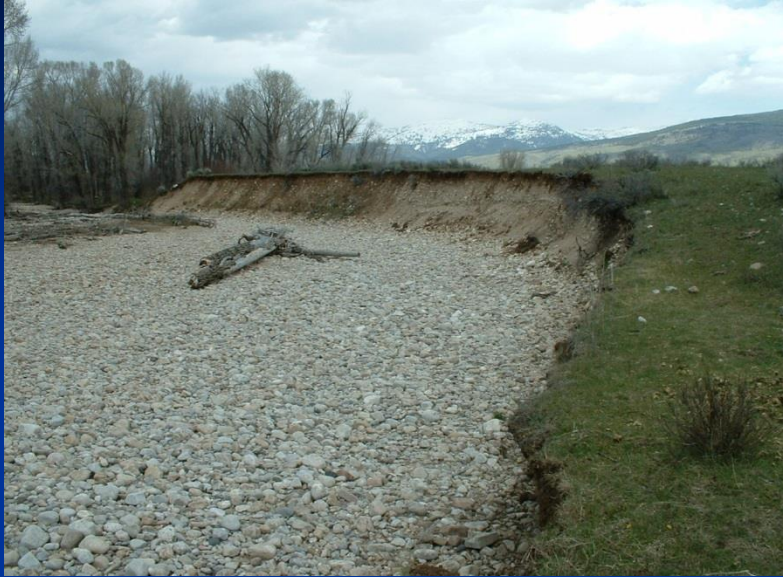
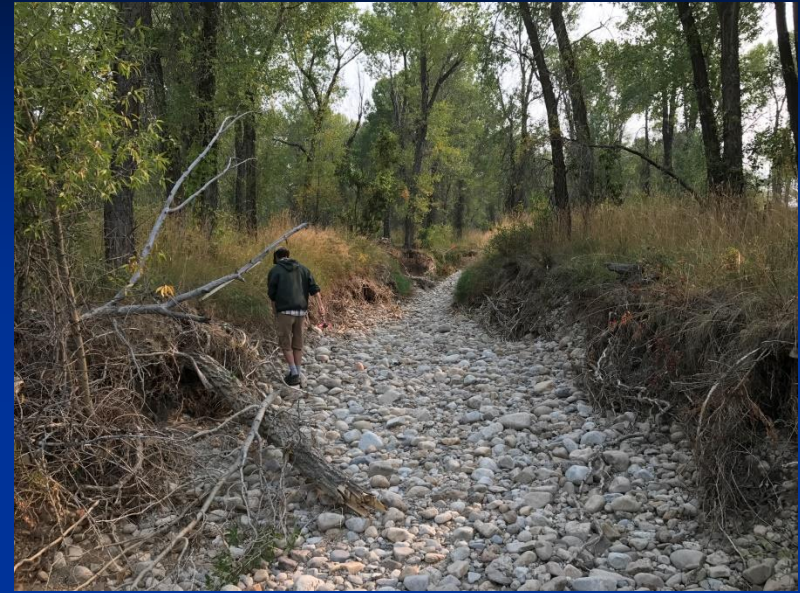
Impacts of Excessive Sediment

100 tons of sediment washed-out of this channel in 2011

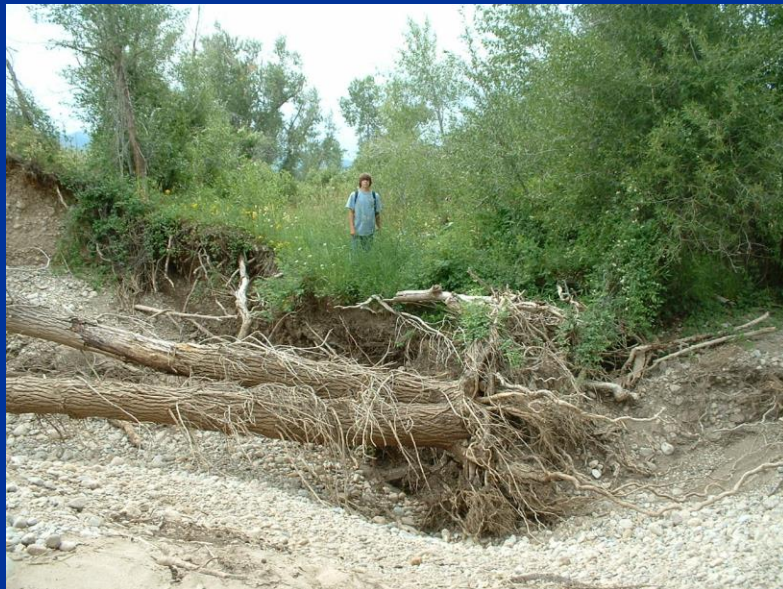
Excessive sediment "choked-up" the channel and deflected flows into streambanks and old channels causing erosion and riparian vegetation damage.

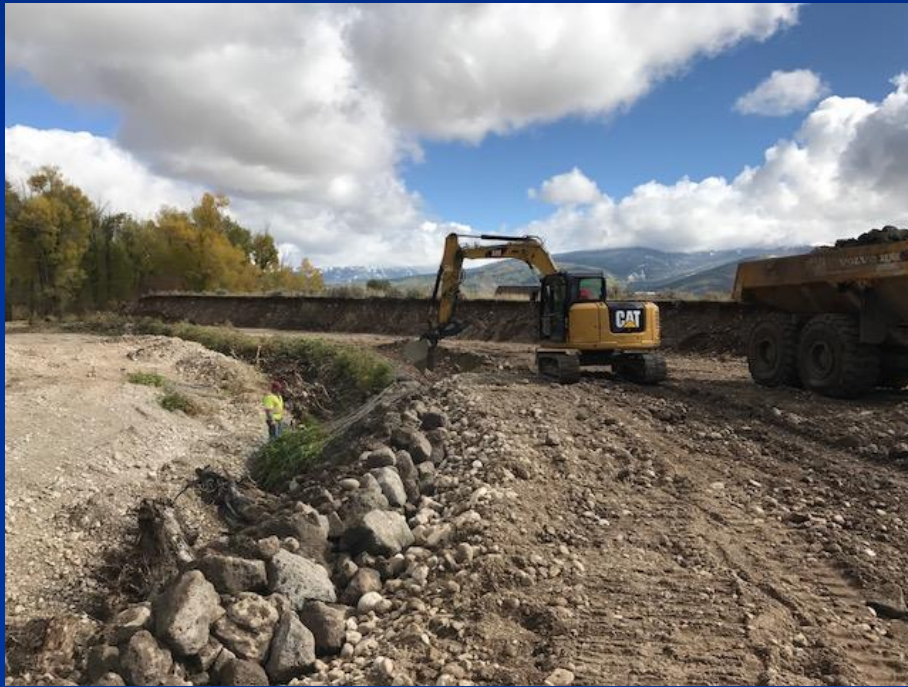
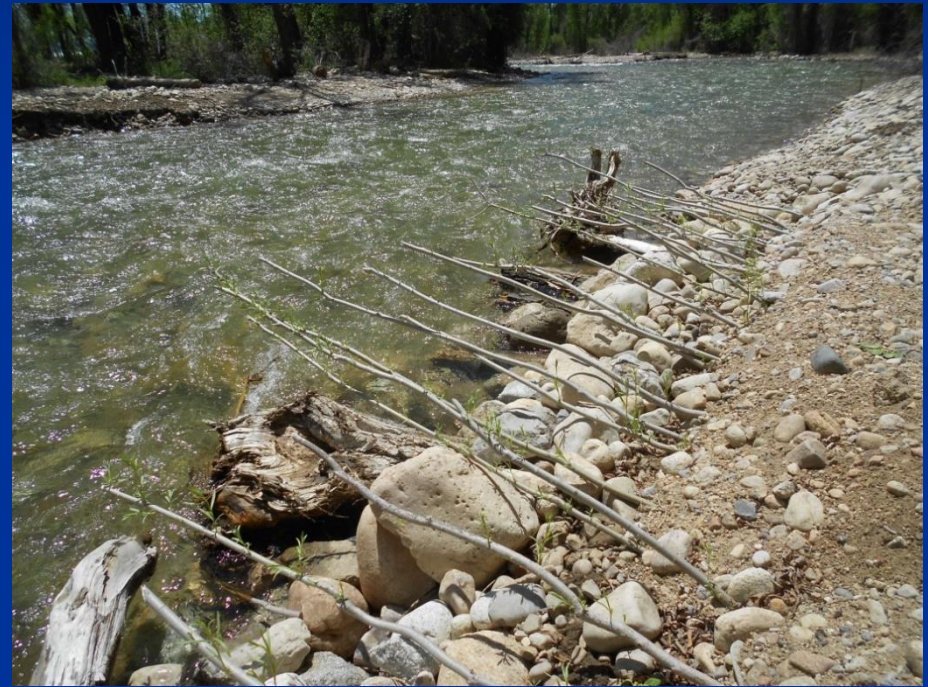
Stabilize Banks Using 'BioEngineered' Structures

Rocks, anchored trees/roots, willows, and vegetation

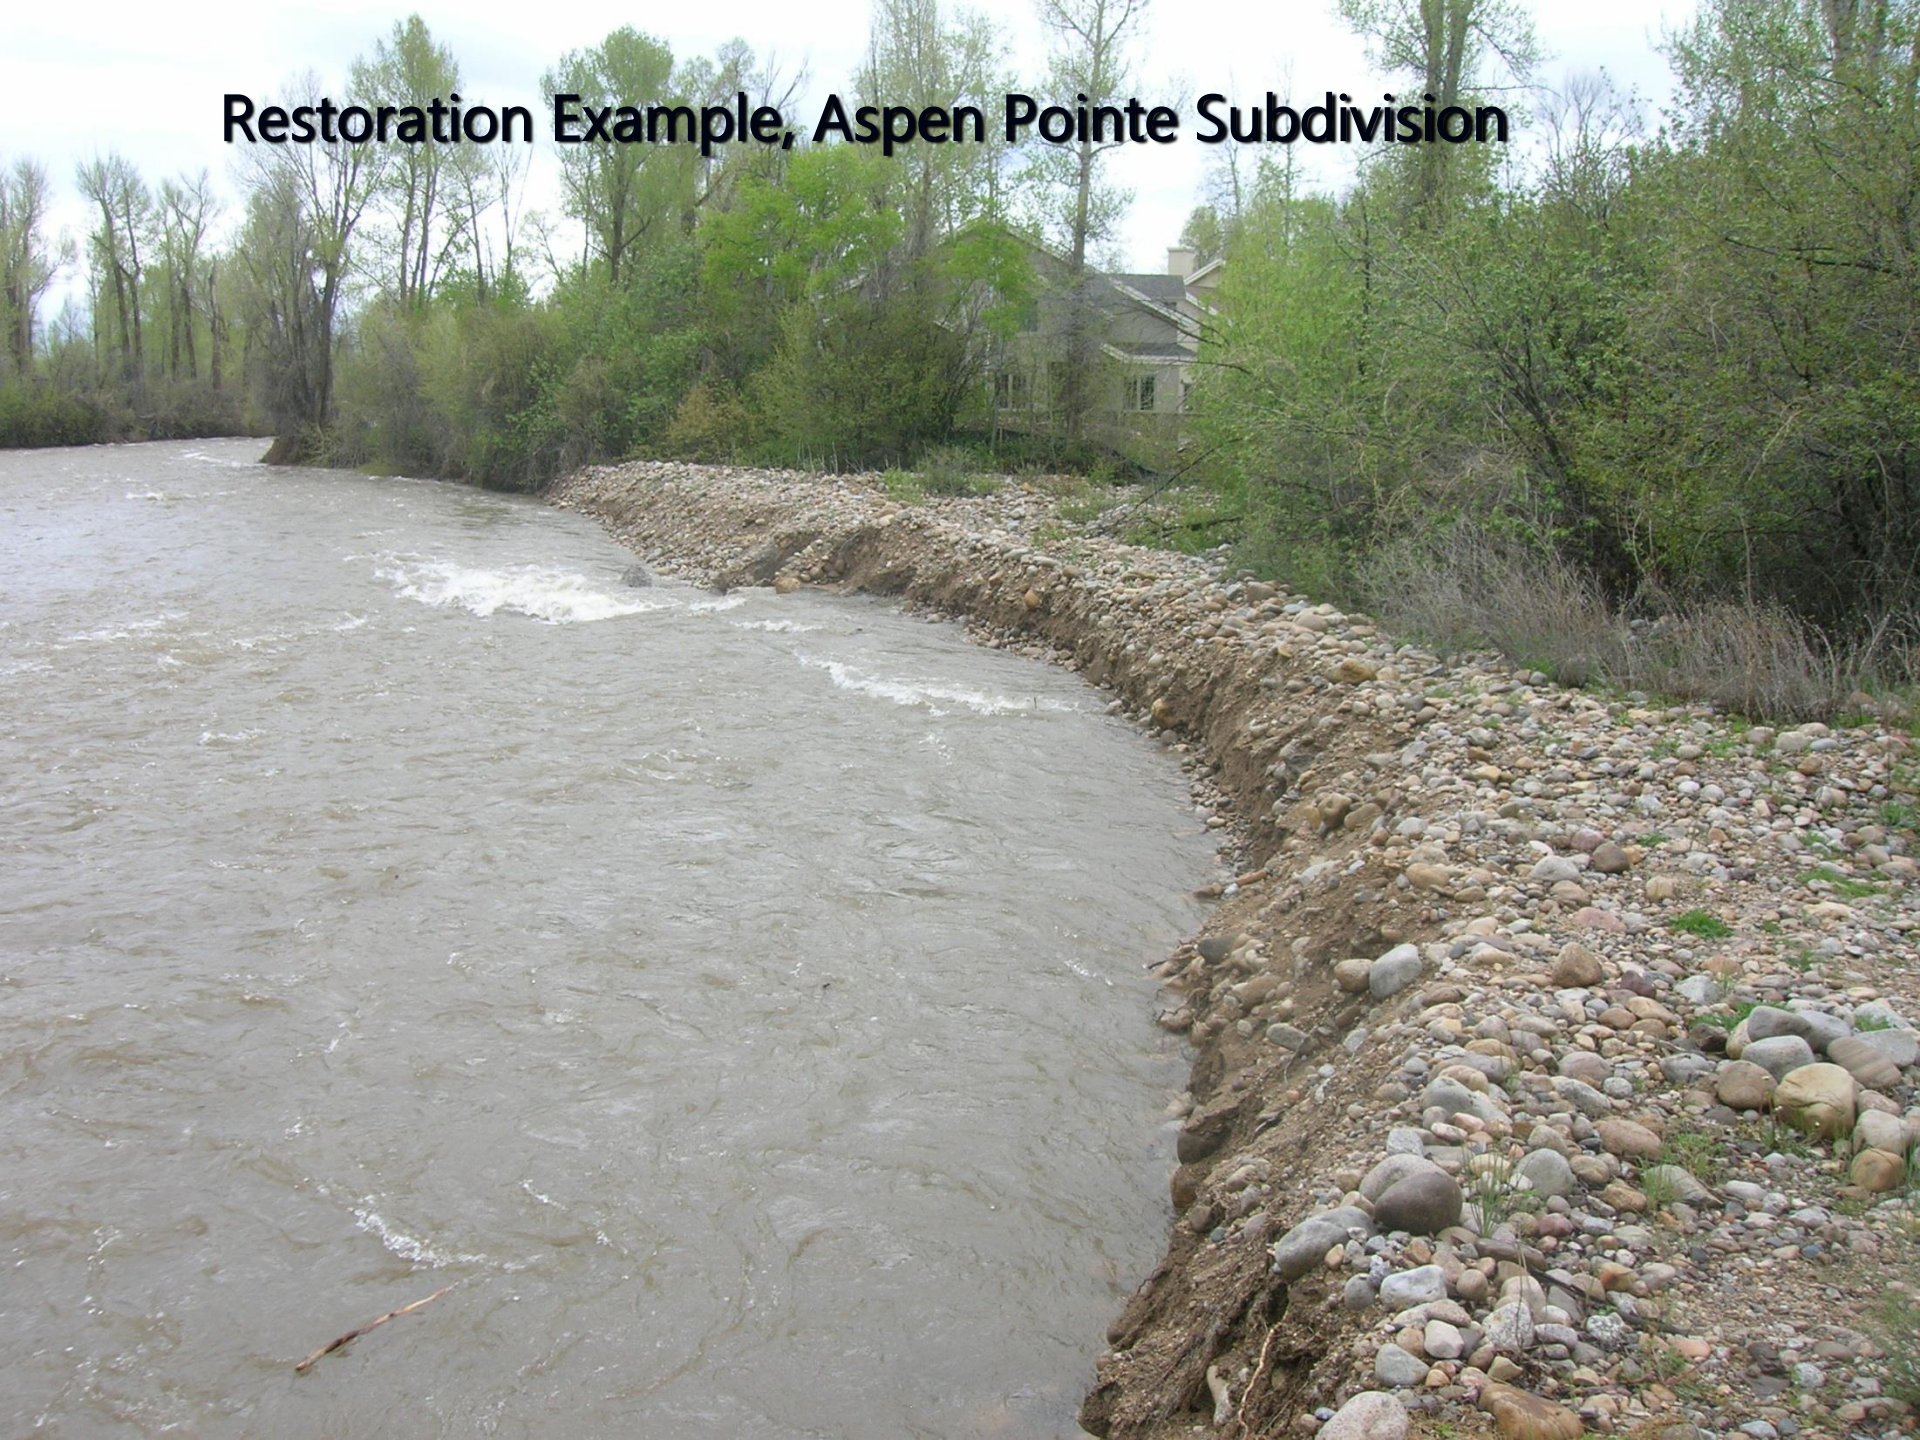
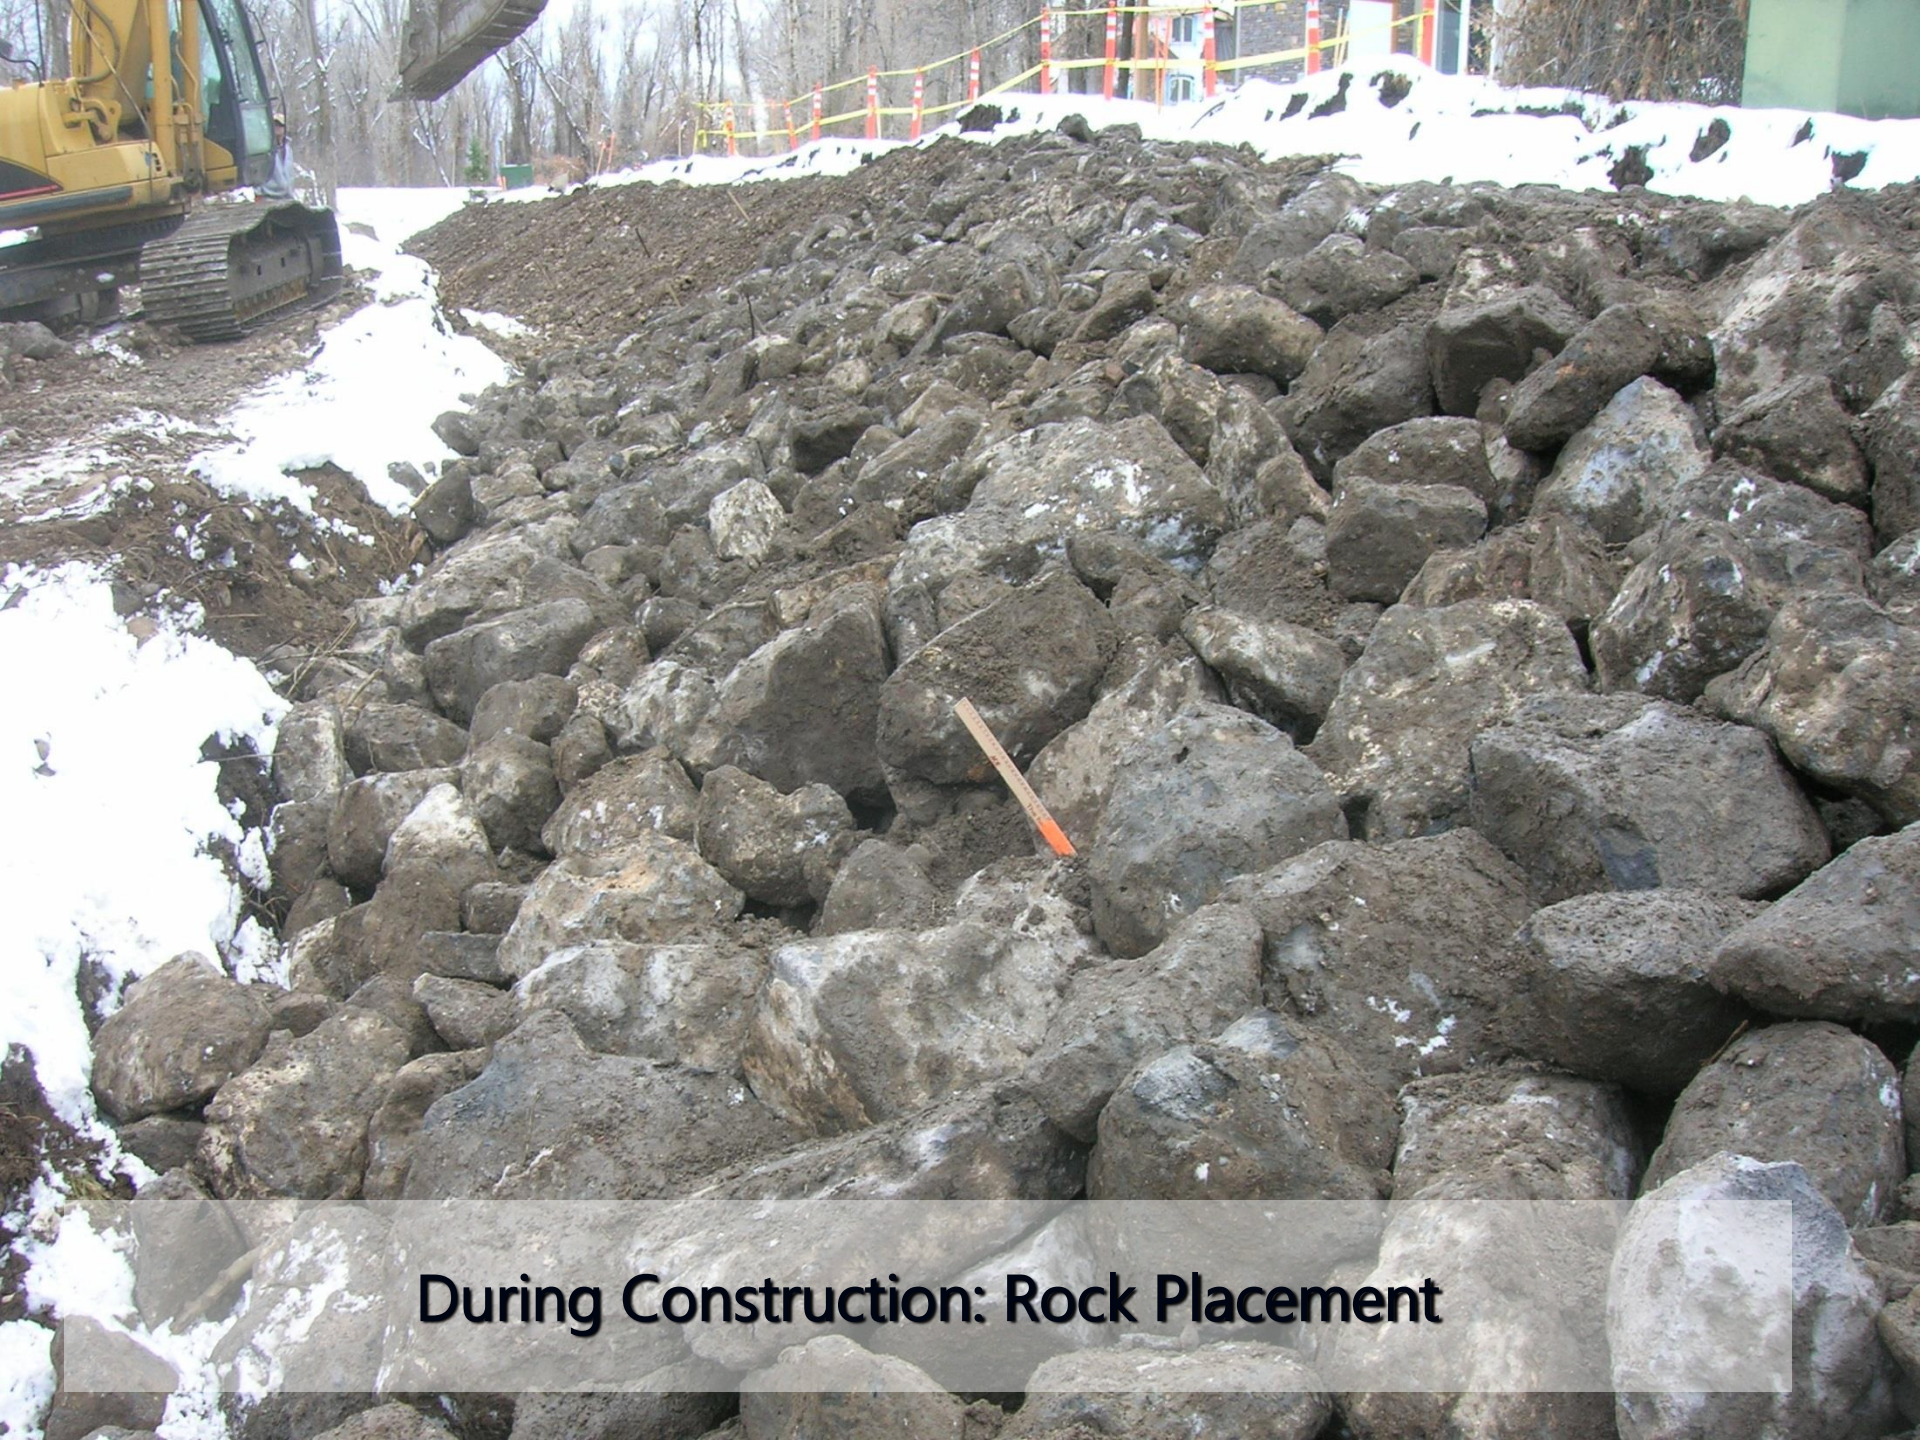
During Construction: Rock Placement

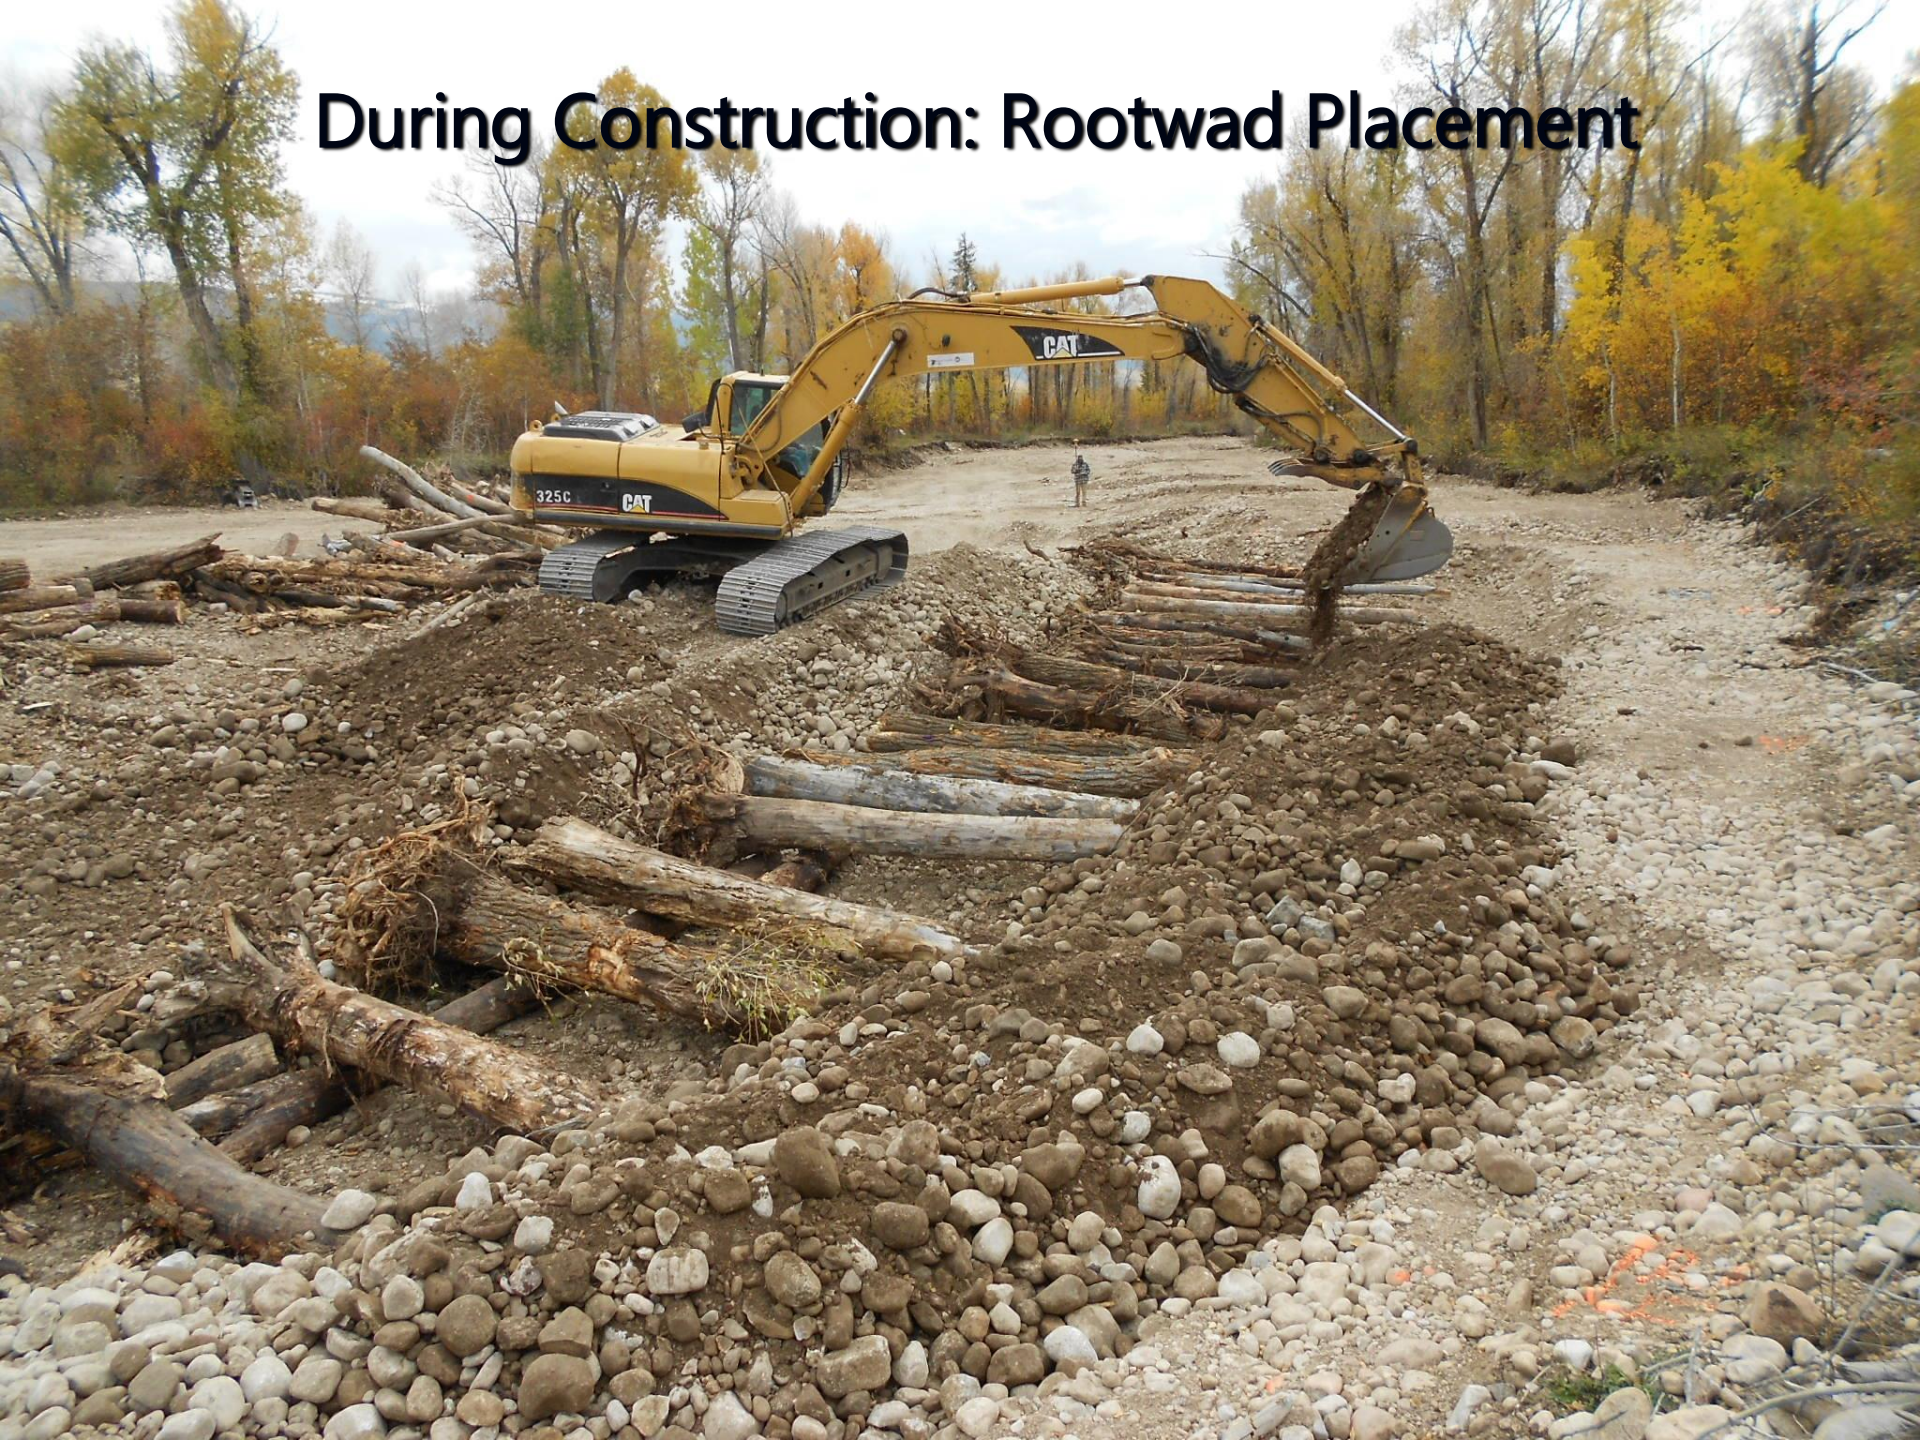
During Construction: Rootwad Placement

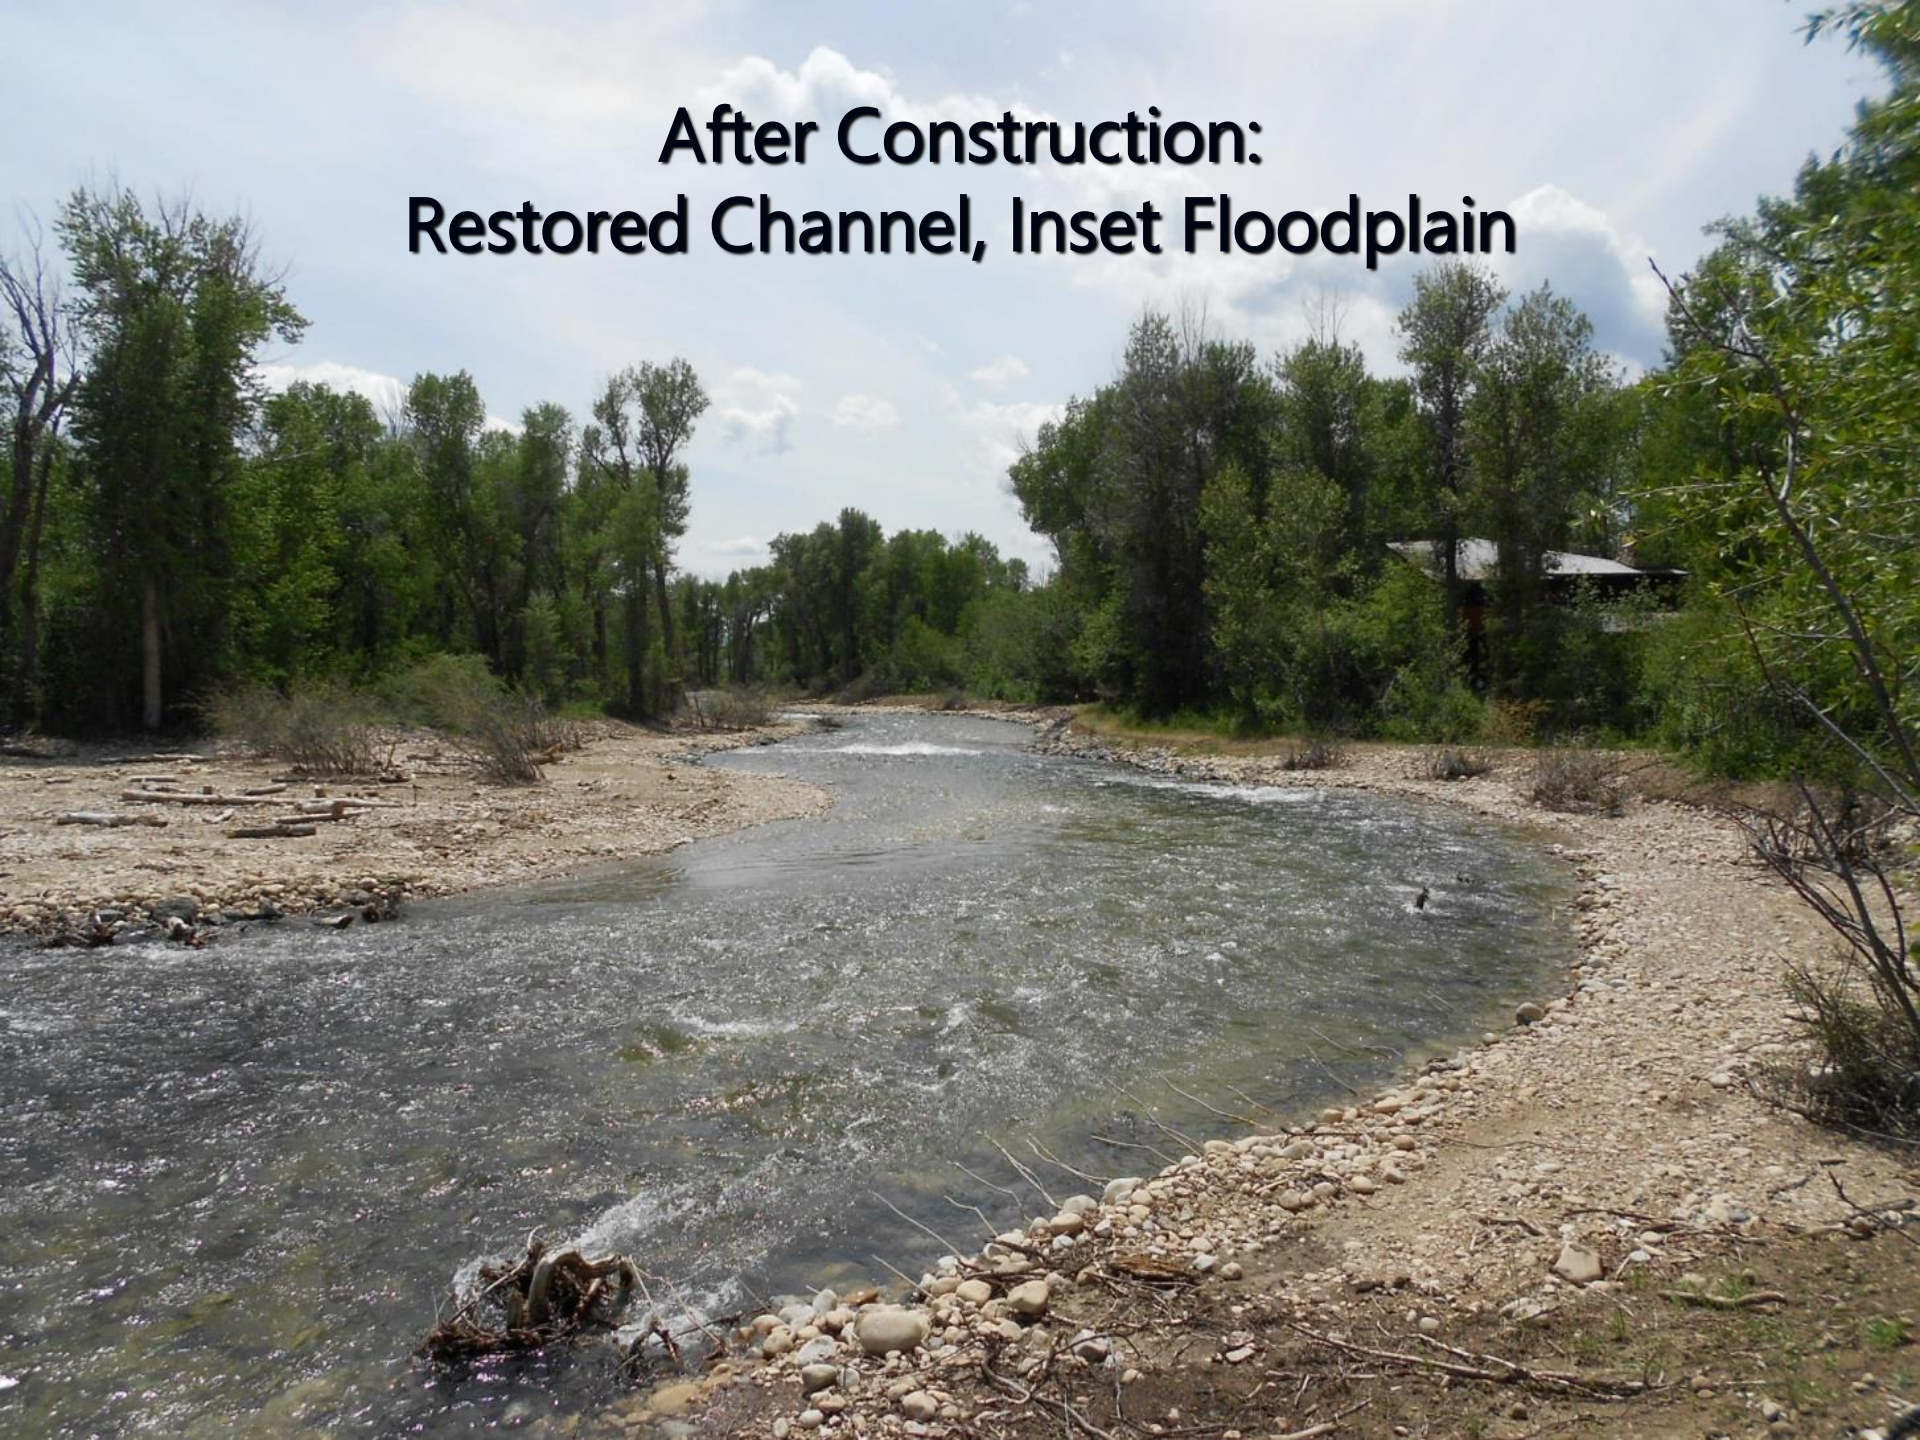
After Construction: Restored Channel, Inset Floodplain

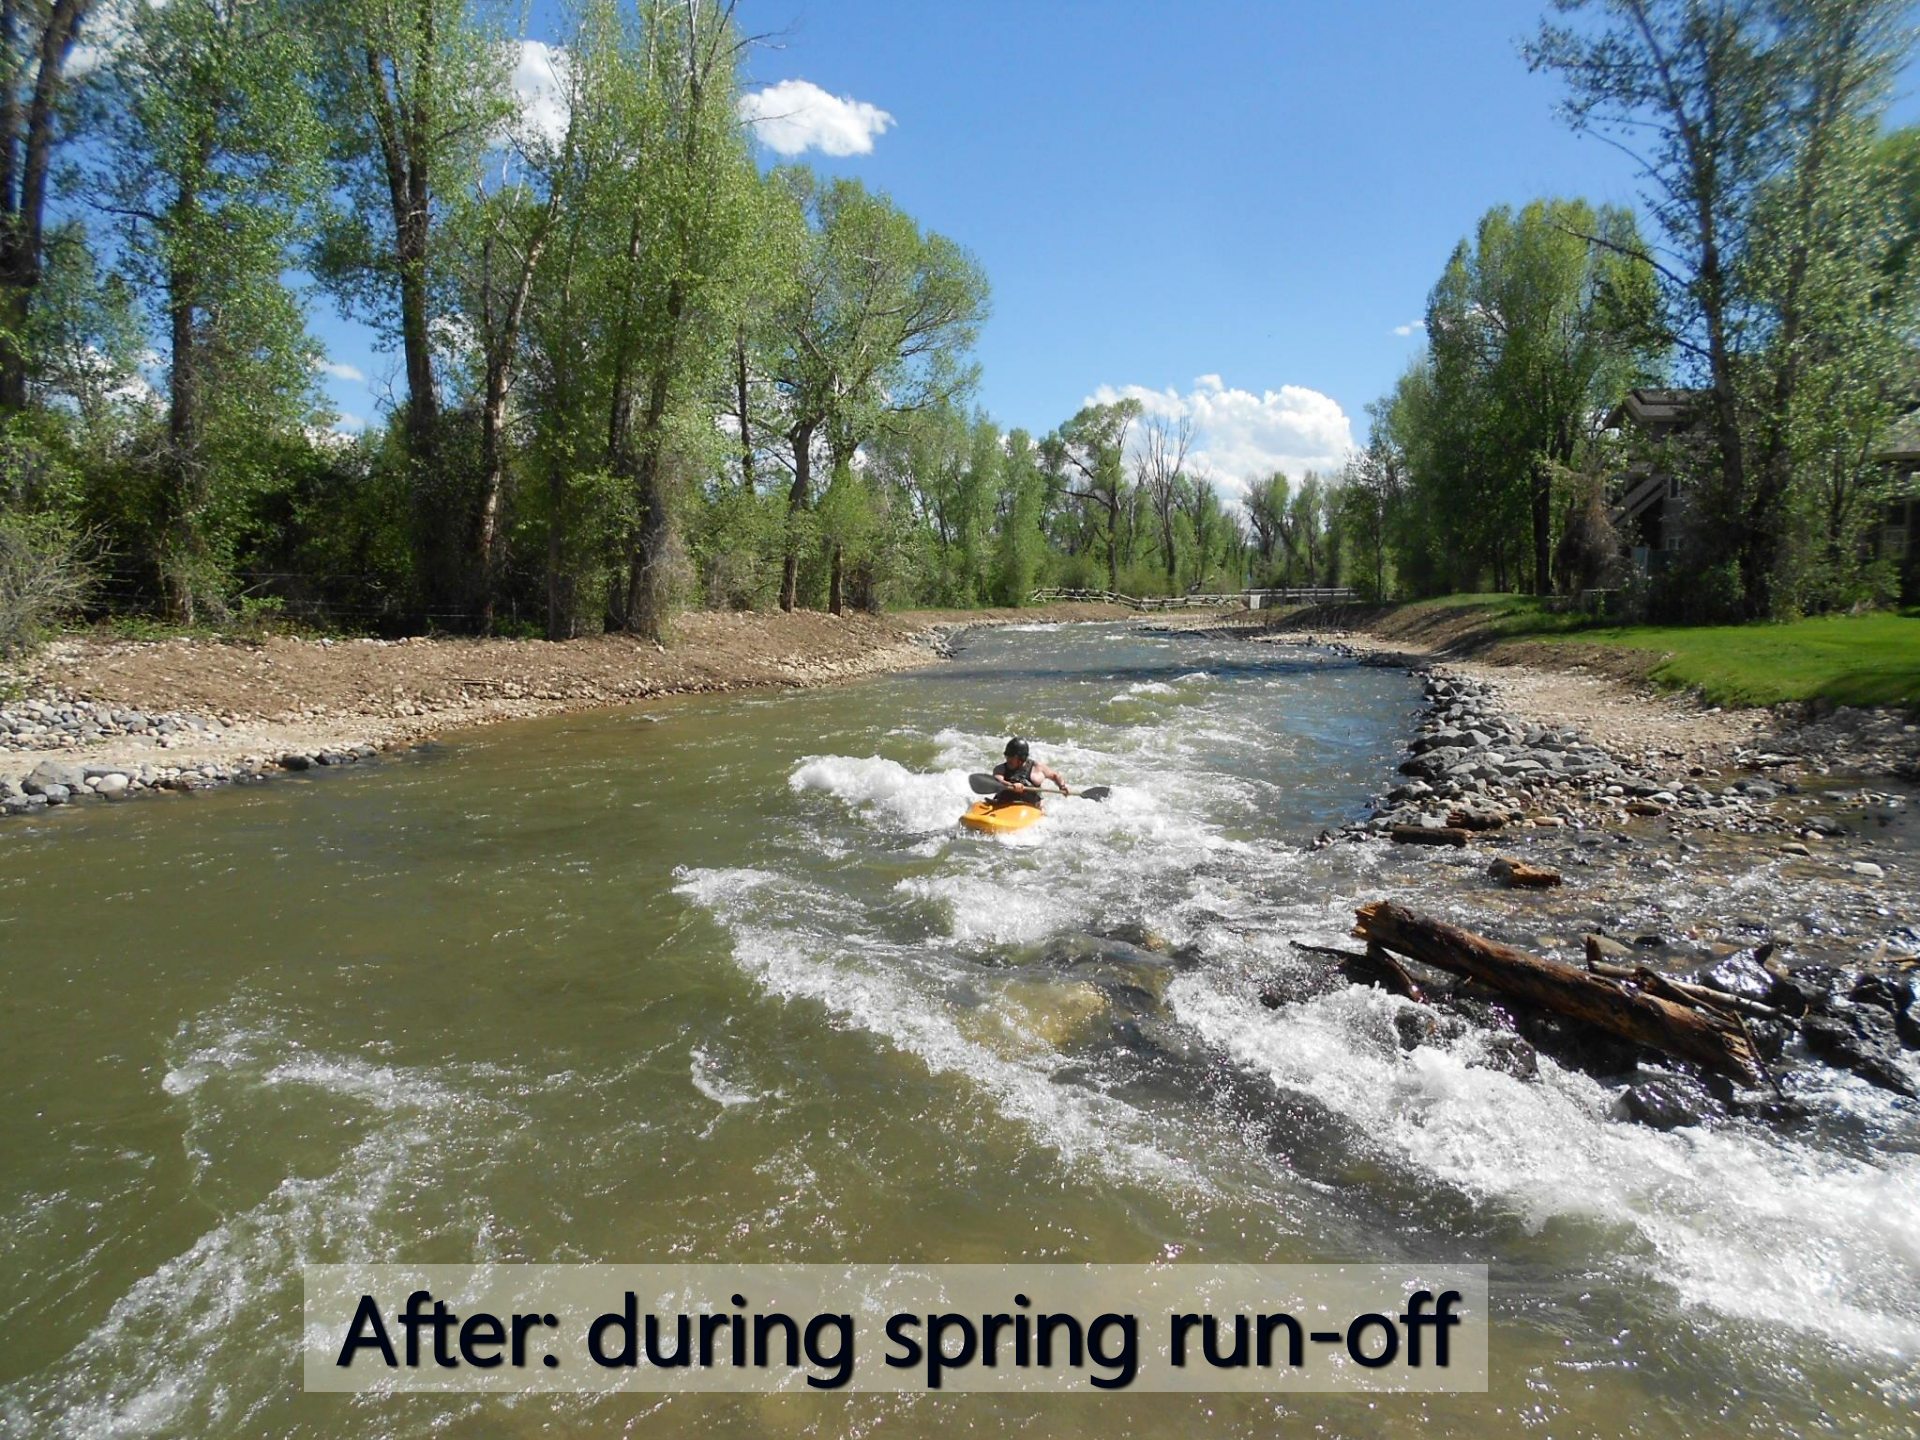
After: during spring run-off
