GEOMORPHIC ASSESSMENT REPORT
TETON CREEK
TETON COUNTY, IDAHO

August 22, 2017

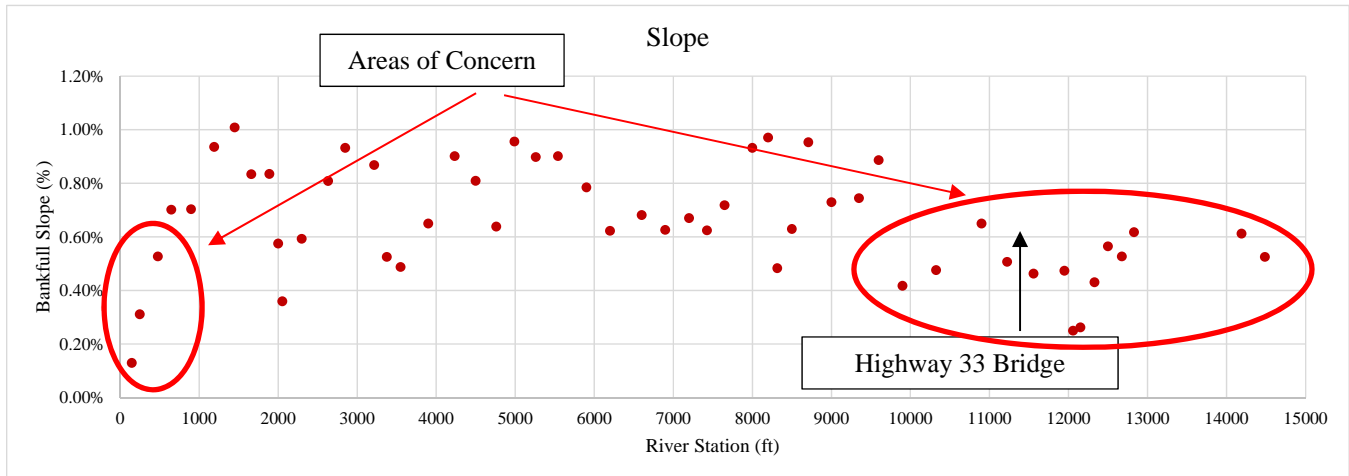
Figure 31. Chart of bankfull channel slope values within the Assessment Reach.

Bankfull channel slope was calculated for more than 50 sub-reach of Teton Creek associated with analyzed riffle bed feature locations. Bankfull slope in the Assessment Reach ranges from 0.13% to 1.01%, and the reach as a whole has an average slope of 0.66% with standard deviation of 0.21% (Figure 31). The reach of Teton Creek located upstream of the Cemetery Road Bridge has average bankfull slope of 1.1%, and the decreased channel slope within the Assessment Reach is attributed to a transition from the alluvial fan to the broad wide valley floor of the Teton River.

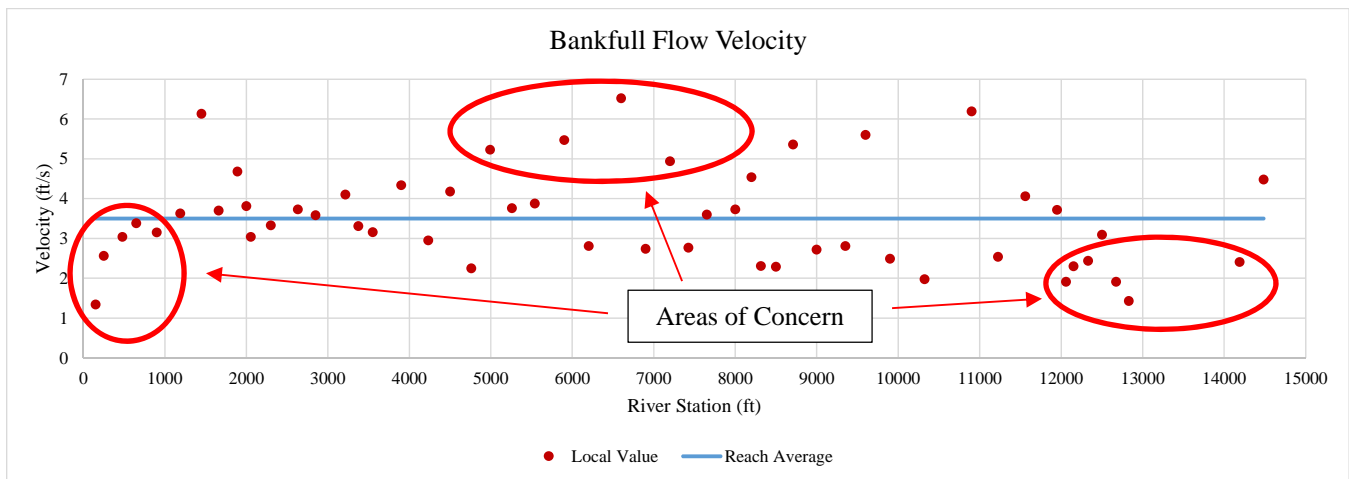
Figure 32. Chart of bankfull flow velocity values within the Assessment Reach.

Bankfull flow velocity was calculated for more than 50 sub-reach of Teton Creek associated with analyzed riffle bed feature locations. Bankfull velocity in the Assessment Reach ranges from 1.34 ft/s to 6.52 ft/s, and the reach average velocity is 3.50 ft/s and standard deviation is 1.21 ft/s (Figure 32). The bankfull flow velocity is generally consistent throughout the Assessment Reach, with notable exceptions within a sub-reach located downstream of Cemetery Road Bridge and in sub-reaches located proximate to the Highway 33 Bridge.

Downstream of the Cemetery Road Bridge, decreased flow velocity in the primary channel is observed in an area where the channel is braided and meander cutoff channels are forming. In the middle of the Assessment Reach (from Station 50+00 ft to 80+00 ft) elevated flow velocities are observed in a reach

that has relatively low sinuosity and moderate lateral confinement. Downstream of the bridge influence (Station 125+00 ft to 135+00 ft) decreased flow velocities are observed proximate to the debris blockage of the primary channel. Sheet 11 (attached) depicts the bankfull flow velocity of sub-reaches with a chloropleth map that identifies prioritized areas of concern due to discrepancies in velocity; sub-reaches depicted in pink and beige have minimal channel slope, and sub-reaches depicted in red have elevated channel slope.

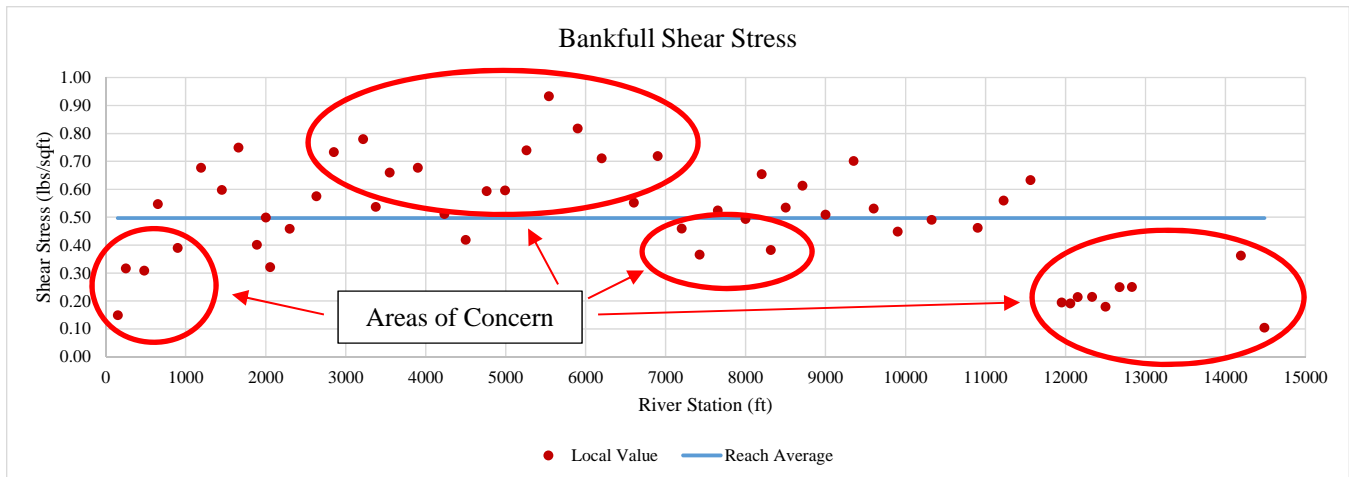
Figure 33. Chart of bankfull shear stress values within the Assessment Reach.

rap). Elevated shear stress is also observed proximate to the Highway 33 Bridge where the bridge configuration eliminates floodplain conveyance and results in confinement of peak flows within the channel. These areas are of concern because elevated shear stress results in increased force imposed on the channel bed and banks, which results in increased erosive potential.

Areas of concern due to reduced shear stress are located downstream of Cemetery Road Bridge and in Creekside Meadows where widespread aggradation is observed. An extended sub-reach with reduced shear stress is located proximate to the debris blockage downstream of the Highway 33 Bridge (Station 130+00 ft). Sheet 12 (attached) depicts the bankfull shear stress of sub-reaches with a chloropleth map that identifies prioritized areas of concern due to discrepancies in shear stress; sub-reaches depicted in pink have minimal shear stress, and sub-reaches depicted in red have elevated shear stress.

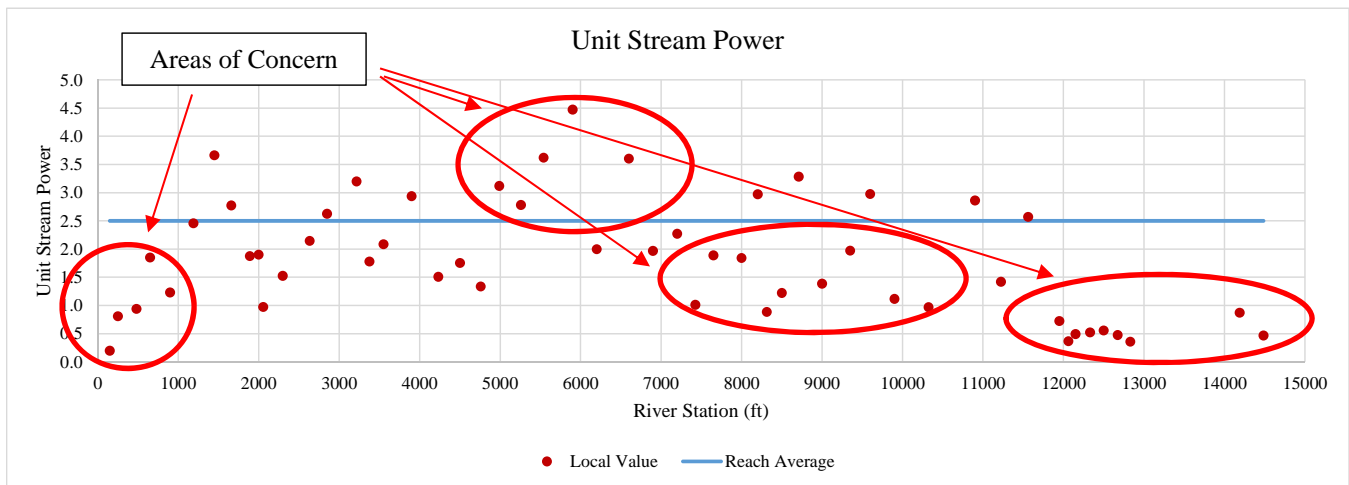
Figure 34. Chart of bankfull unit stream power values within the Assessment Reach.

Sub-reaches with elevated stream power are generally located in the middle of the Assessment Reach (Station 50+00 ft to 75+00 ft) where the river is relatively straight and confined by bank armoring (rip rap). Elevated stream power is also observed proximate to the Highway 33 Bridge where the bridge configuration eliminates floodplain conveyance and results in confinement of peak flows within the channel. These areas are of concern because elevated stream power results in increased ability of the system to alter the channel bed and banks through erosive processes.

A sub-reach with reduced stream power was identified downstream of Cemetery Road Bridge in an area of channel braiding and deposition. Additional areas of concern due to reduced stream power are located in Creekside Meadows where widespread aggradation is observed (Station 80+00 ft to 100+00 ft), and proximate to the debris blockage downstream of the Highway 33 Bridge (Station 125+00 ft to 140+00 ft). Sheet 13 (attached) depicts the unit stream power stress of sub-reaches with a chloropleth map that

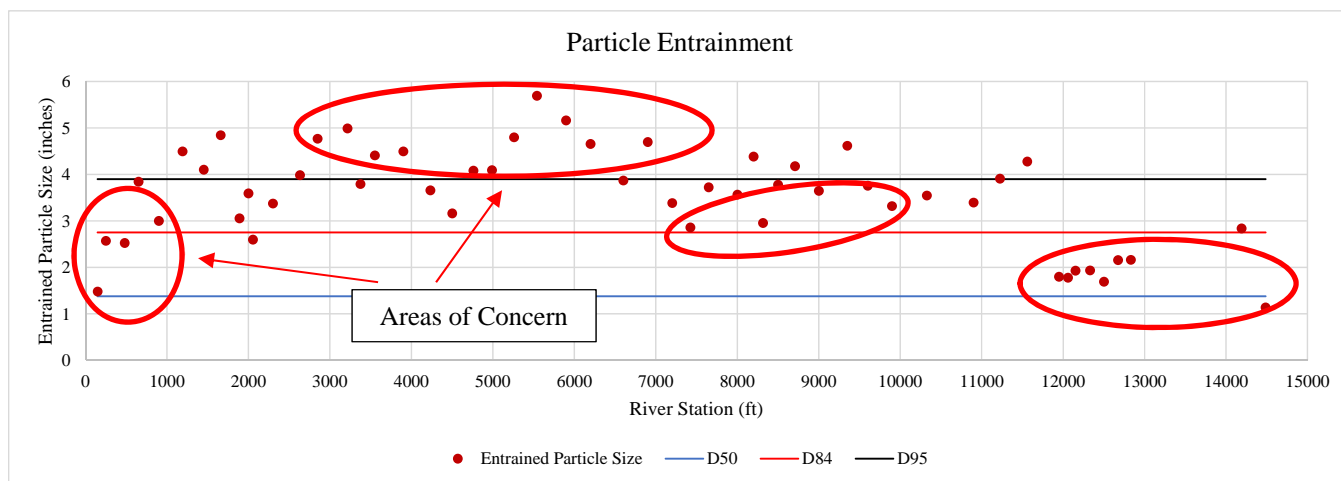
Figure 35. Chart of sediment transport competence (grain size) values within the Assessment Reach.

Sediment transport competence, or the ability of a river to entrain substrate based upon particle size, was quantified for more than 50 sub-reach of Teton Creek associated with analyzed riffle bed feature locations. Calculated dimensional shear stress values were used to identify the size particle entrained at bankfull discharge based upon a modified Shields curve depicting the incipient motion of sediment particles based on shear stress. Sub-reaches of the Assessment Reach are competent to mobilize surface grains with maximum sizes ranging from 1.1 to 5.7 inches, and the average reach condition is competent to mobilize particles up to 3.5 inches in diameter (Figure 35).

Transport competence results were compared to the surface grain size class distribution to assess potential for the channel to mobilize stream bed material. Sediment transport analysis indicates areas of concern within the Assessment Reach where competence is high and there is potential for channel degradation (lowering), and where competence is low and there is potential for aggradation (sedimentation).

Sub-reaches with elevated sediment transport competence are generally located in the middle of the Assessment Reach (Station 25+00 ft to 80+00 ft) where the river is relatively straight and confined by bank armoring (rip rap). Elevated sediment transport competence is also observed proximate to the Highway 33 Bridge where the bridge configuration eliminates floodplain conveyance and results in confinement of peak flows within the channel. These areas are of concern because increased sediment transport competence could result in mobilization of substrate and degrading (lowering) of the stream channel.

A sub-reach with reduced sediment transport competence was identified downstream of the Cemetery Road Bridge (Station 10+00 ft) in a sub-reach with excessive channel width where deposition is resulting in channel filling. Additional areas of concern due to reduced sediment transport competence are located in Creekside Meadows where widespread aggradation is observed (Stations 75+00 ft, 85+00 ft, and 10+00 ft), and proximate to the debris blockage downstream of the Highway 33 Bridge (Station 125+00 ft to 140+00 ft). Sheet 14 (attached) depicts the sediment transport competence of sub-reaches with a chloropleth map that identifies prioritized areas of concern due to discrepancies in competence; sub-reaches depicted in pink have minimal sediment transport competence, and sub-reaches depicted in red have elevated sediment transport competence.

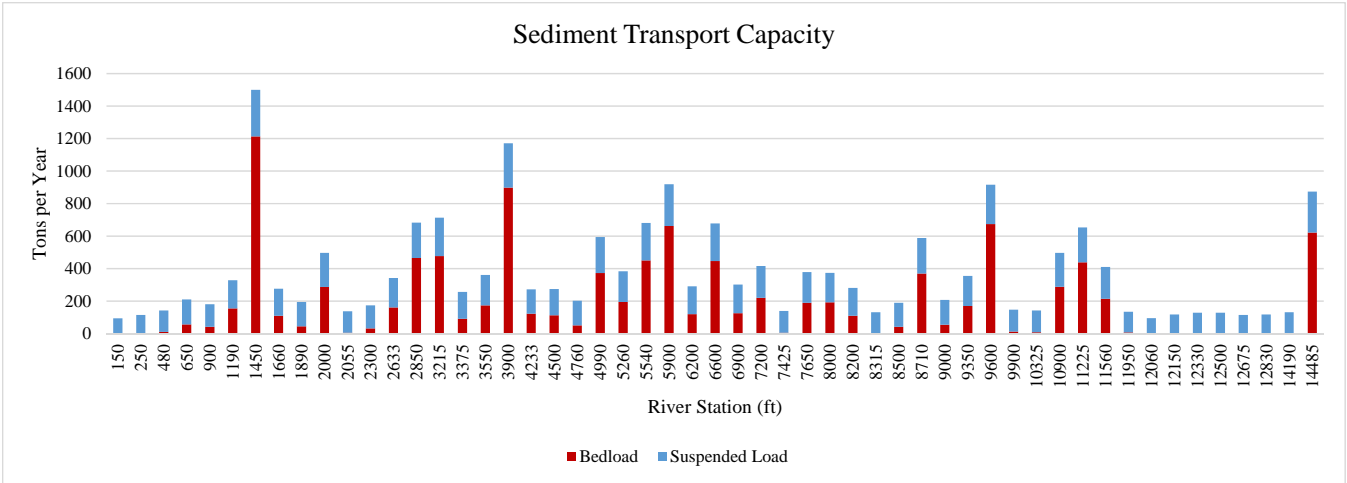
Figure 37. Chart of sediment transport capacity within the Assessment Reach.

Sediment transport capacity in the Assessment Reach ranges from 93 tons/yr to 1,499 tons/yr, and the reach average capacity is 370 tons/yr. Total annual sediment transport capacity of analyzed sub-reaches of Teton Creek are depicted in Figure 37, in which bedload capacity is depicted in red, suspended load capacity is depicted in blue, and the total sediment capacity is depicted by the total (summed) height of the bars in the chart.

Available analysis and data indicate that the reach of Teton Creek located upstream of the Cemetery Road Bridge supplies approximately 1,900 tons/yr of sediment to the Assessment Reach. In general, the Assessment Reach has insufficient sediment transport capacity to convey the sediment load supplied from upstream of Cemetery Road Bridge. The percentage of the total supplied load that could be conveyed by each analyzed sub-reach in the Assessment Reach is presented in Figure 38. The majority of the Assessment Reach has capacity to transport less than 50% of the supplied sediment load, and more than half of the Assessment Reach has capacity to transport less than a quarter of the supplied sediment load.

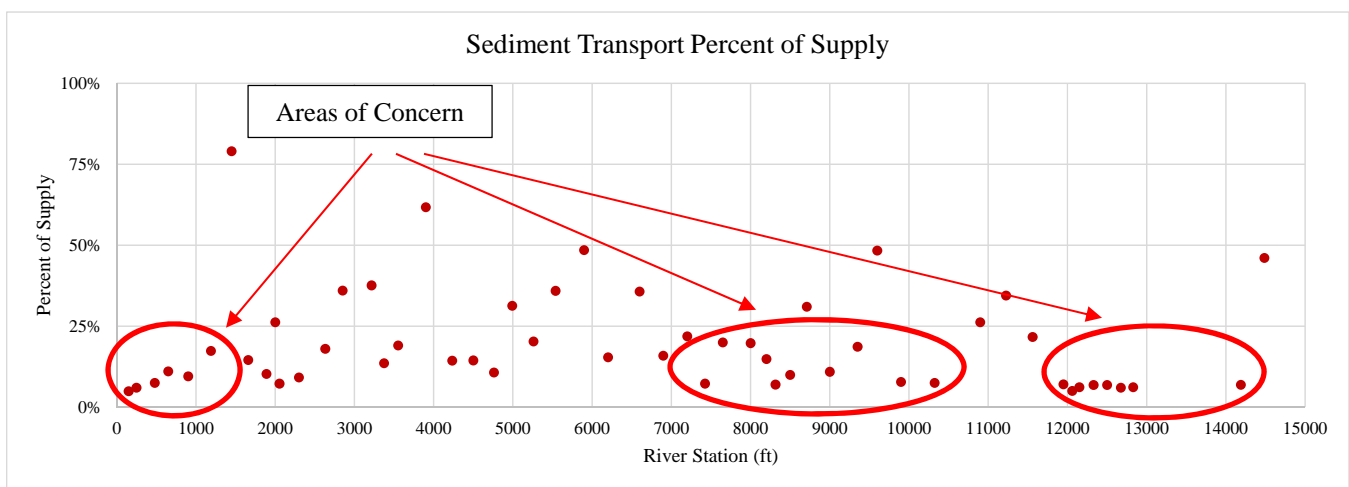
Figure 38. Chart of sediment transport capacity as a percentage of the sediment load supplied to the Assessment Reach from the upper reaches of Teton Creek.

(Station 0+00 to 10+00), in Creekside Meadows (Station 7+50 to 110+00), and in the downstream reach proximate to the debris jam blockage of the primary channel (Station 125+00 to 130+00). Sheet 15 (attached) depicts the sediment transport capacity of sub-reaches as a percentage of the supplied sediment load with a chloropleth map that identifies prioritized areas of concern. Sub-reaches depicted in pink and red lack capacity to transport the supplied sediment load. Because the Assessment Reach generally lacks ability to transport the supplied sediment load, the whole reach is depicted in pink and red in the chloropleth map.

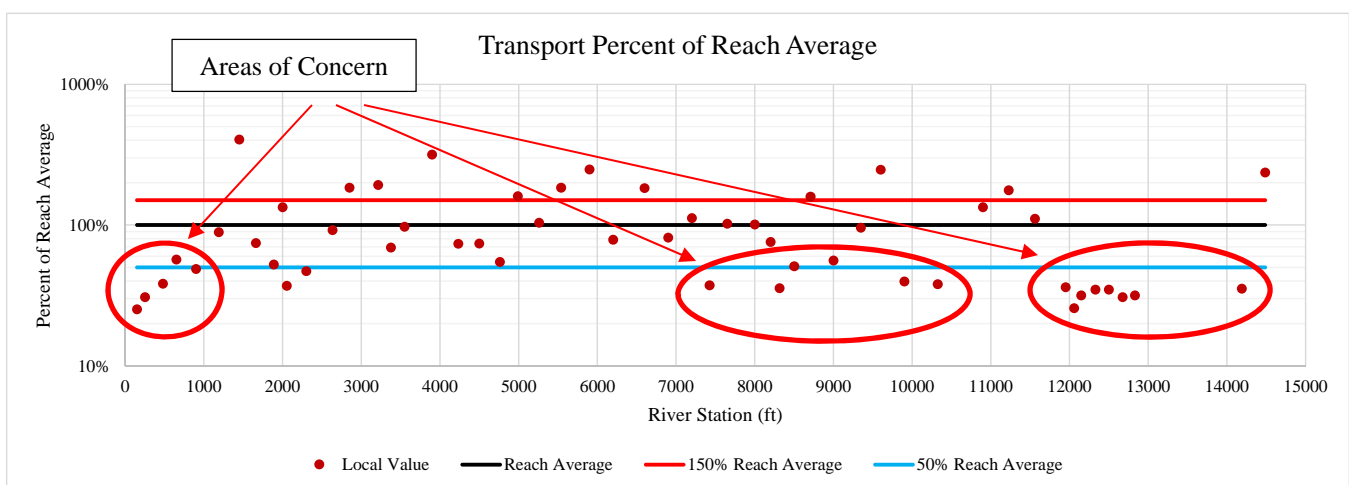
Figure 39. Chart of sediment transport capacity as a percentage of the Assessment Reach average condition.

To further inform the analysis of sediment transport capacity, analysis was completed to quantify sediment transport capacity of sub-reaches as a percentage of the average condition in the Assessment Reach (Figure 39). The analysis identifies three areas where sub-reach sediment transport capacity is less than 50% of the Assessment Reach average condition. These impaired sub-reaches are located downstream of the Cemetery Road Bridge (Station 0+00 to 10+00), in Creekside Meadows (Station 7+50 to 110+00), and downstream of the Highway 33 Bridge (Station 120+00 ft to 140+00 ft).

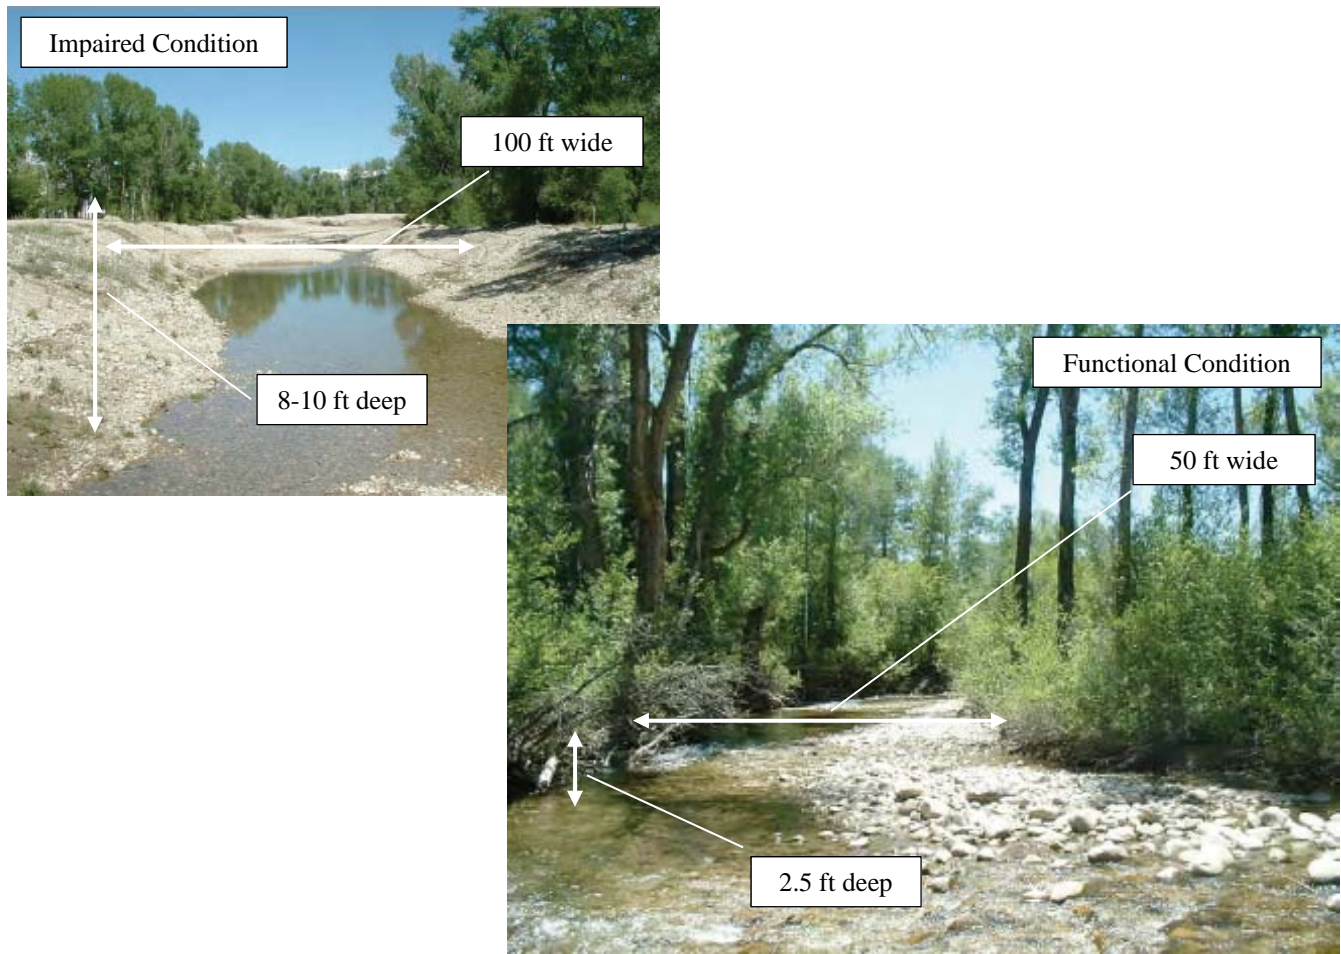
Figure 40. Photographic depicting of impaired channel form compared to functional channel form in Teton Creek.

The functional (restored) channel geometry can be established in impaired reaches through channel narrowing and the establishment of an inset floodplain bench. This treatment type is depicted in Figure 41, in which the placement of alluvium is used to narrow the existing channel and the fill is placed in order to establish a bench at the local floodplain elevation. The bench is then vegetated with native riparian vegetation through installation of vegetative transplants, direct seeding, or passive recruitment.

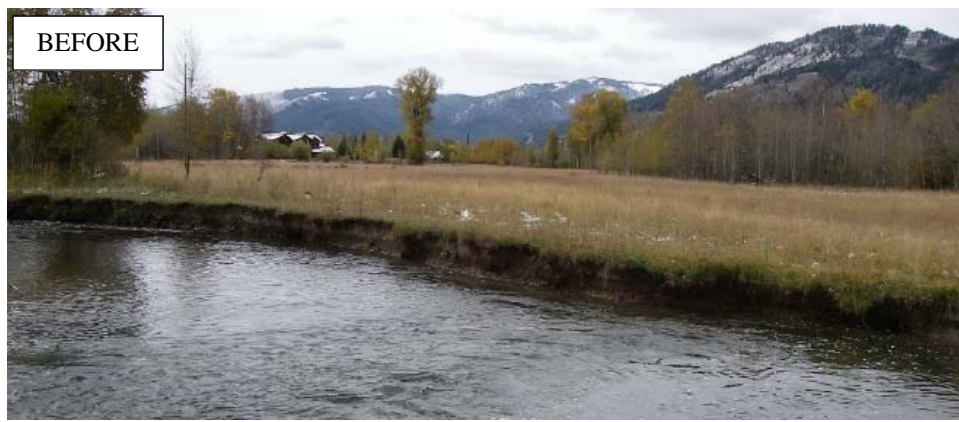
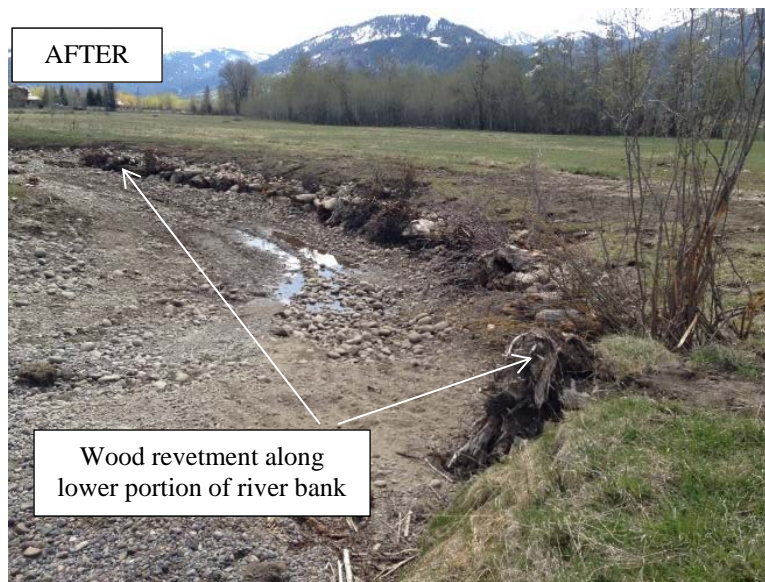
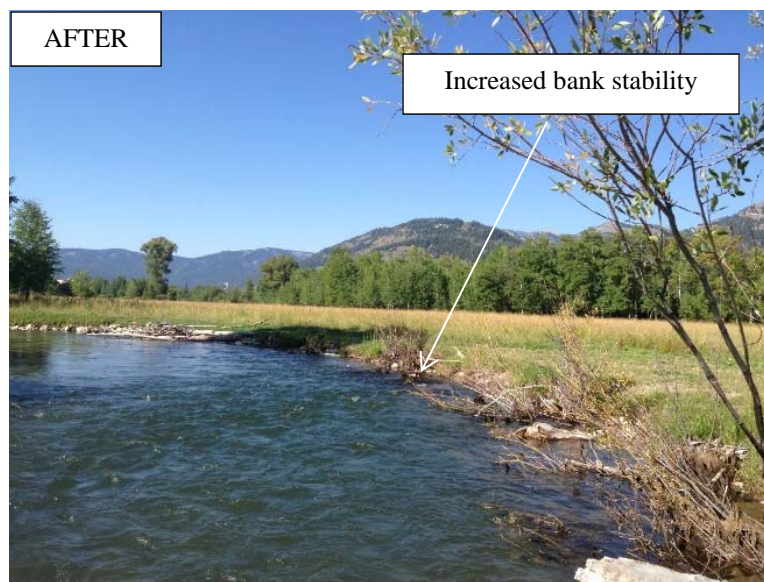
Figure 46. A severely eroding river bank (top) stabilized with the wood revetment treatment (middle). The treatment effectively reduces bank erosion hazard by reducing near-bank flow velocities and shear stress.

The wood revetment bank treatment is depicted visually in Figures 45 and 46 from projects recently completed in the region. Installed large wood (root wads and logs) harden the lower half of the river bank. Ballast and herbaceous vegetation were installed to establish a floodplain bench at the bankfull elevation. The installed large wood protrudes into the channel several feet (below the water surface), which reduces flow velocities, increases bank stability, and provides complex cover for fisheries benefit.

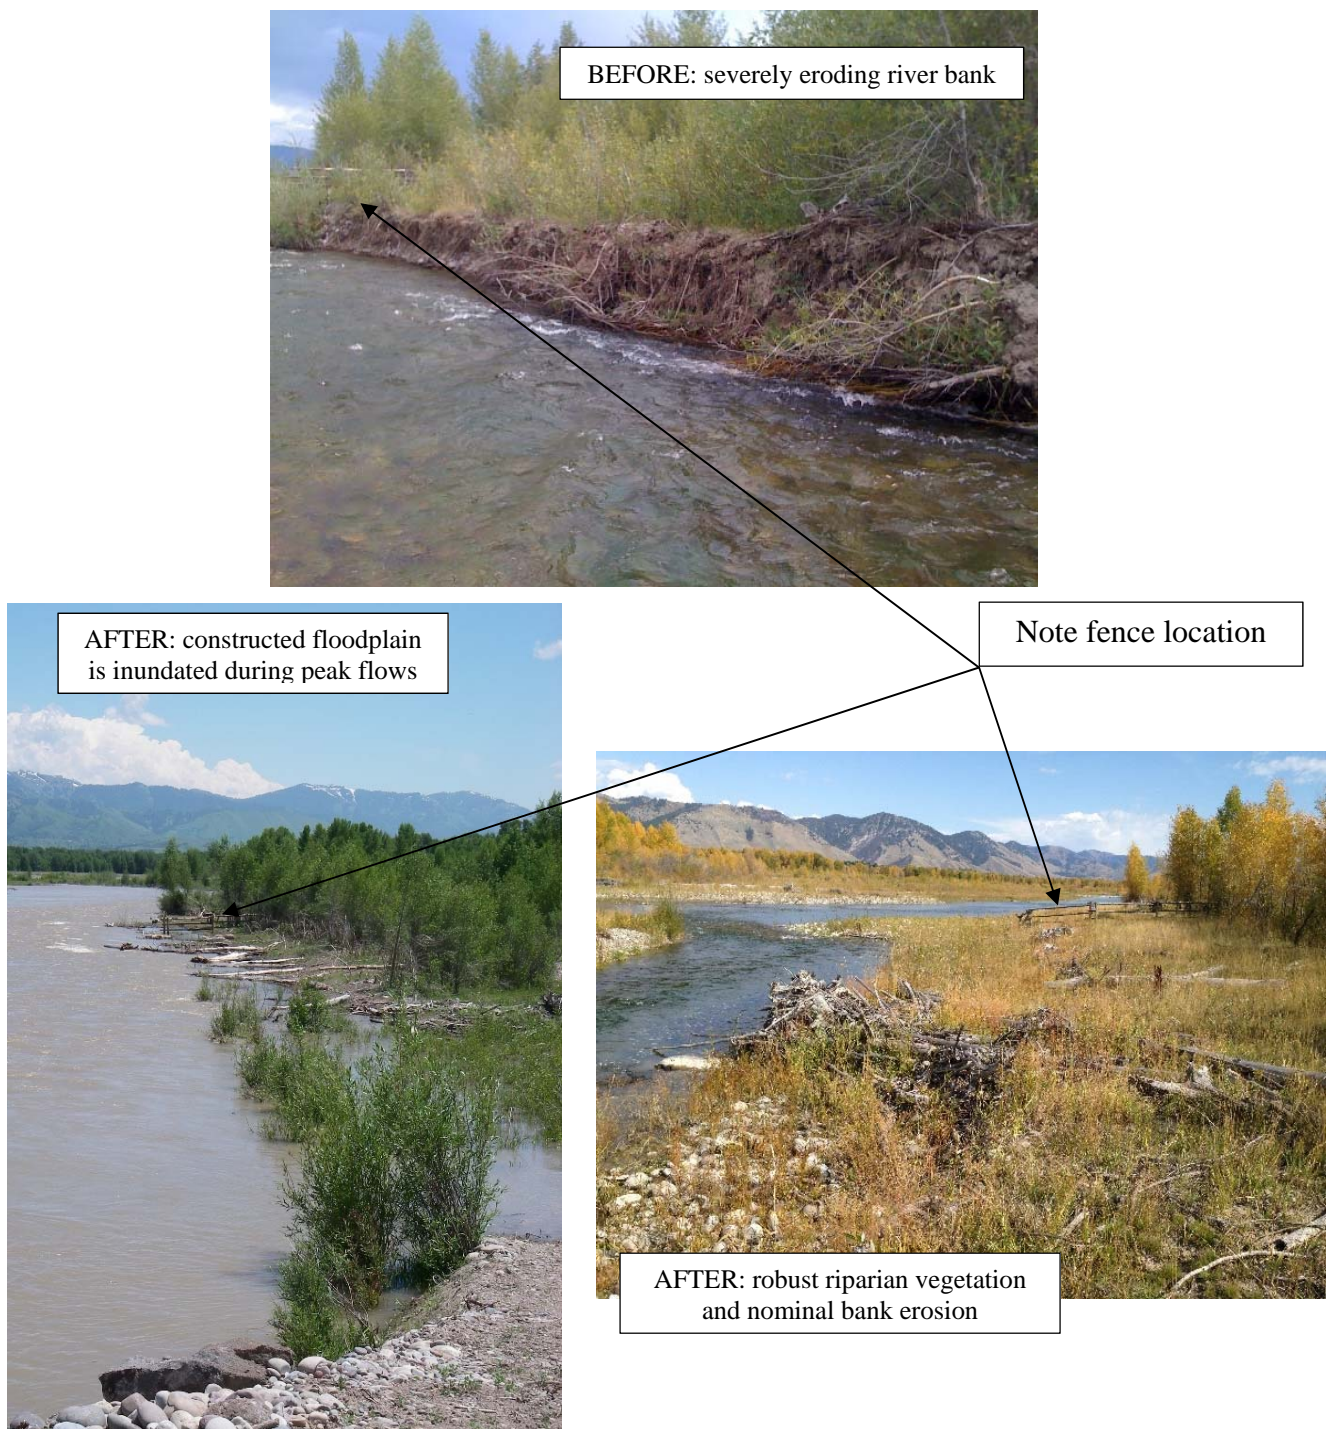
Figure 51. A floodplain bench was created within an over-widened reach of river to eliminate severe bank erosion (top), promote over-land flooding (bottom left), and aquatic conditions and riparian vegetation (bottom right).

Floodplain reconnection and re-establishment is an important component of river system restoration because it enables flood waters to escape the active channel in order to disperse, which reduces erosive energy. Floodplain inundation alleviates erosive potential of the active channel, and could be facilitated within an inset floodplain adjacent to the Teton Creek channel in a manner that accommodates existing proximate residential development and infrastructure. Floodplain restoration is depicted visually in Figures 51 and 52 from projects recently completed in the region.

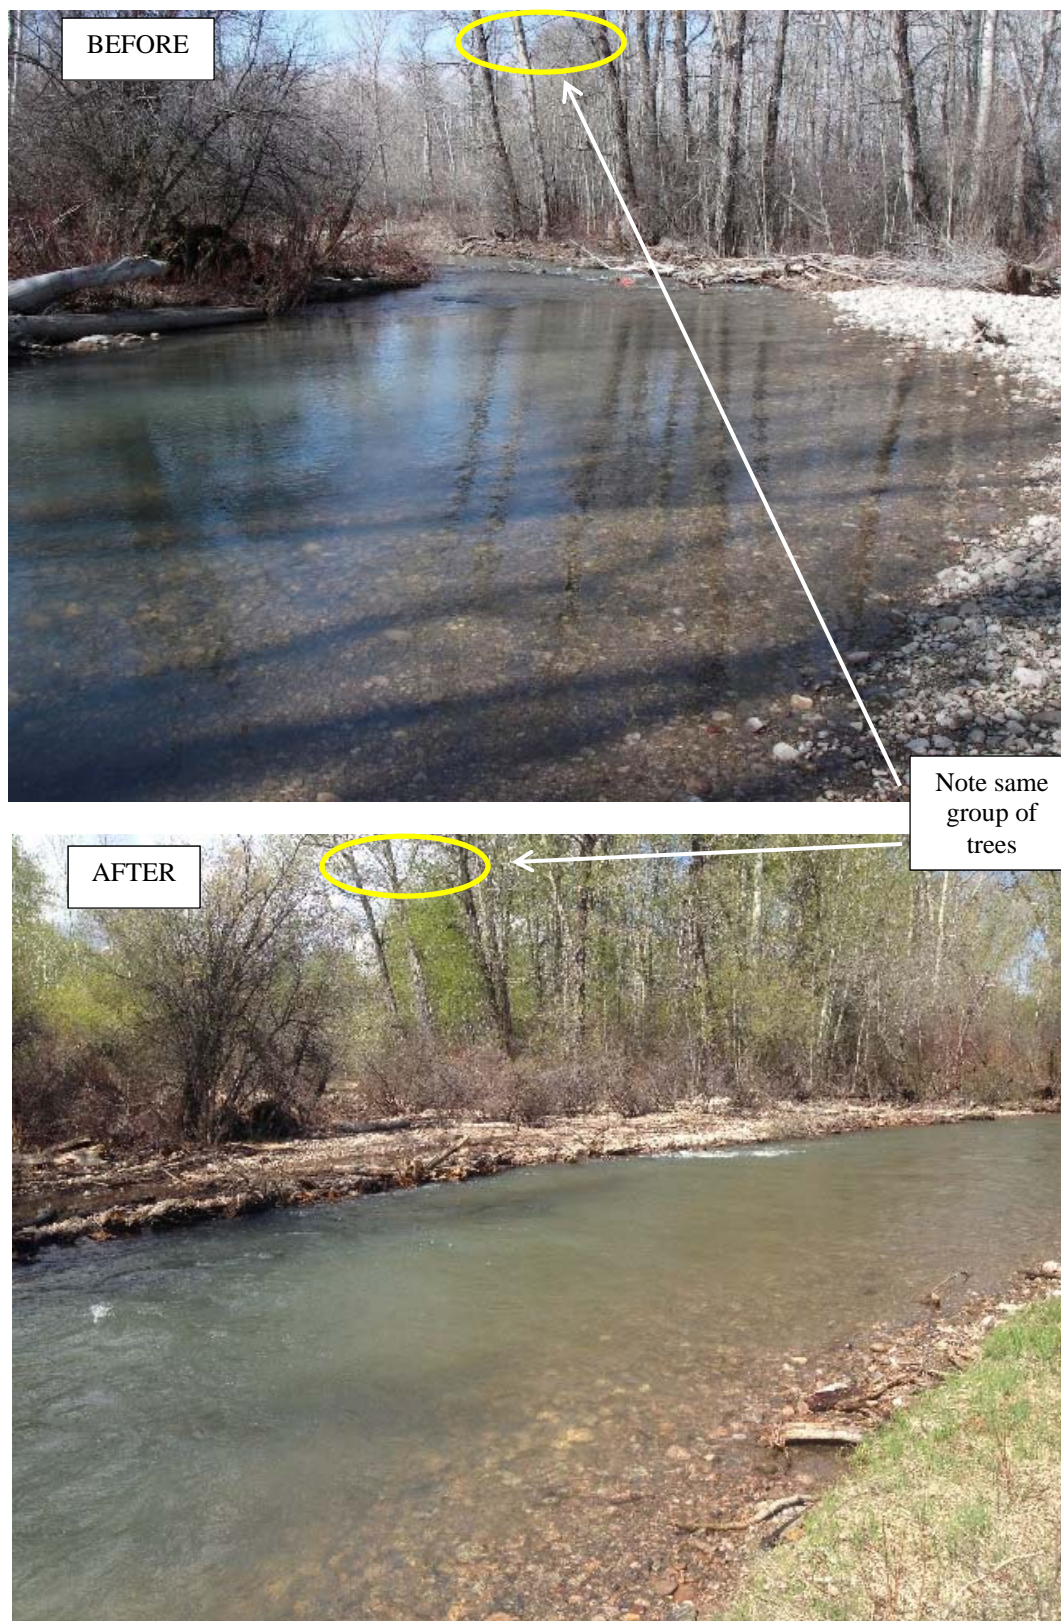
Figure 52. Floodplain creation was used to fill a braided channel network and restore functional channel width within a re-activated historic channel alignment. The treatment achieved flood water dissipation across the floodplain, increased riparian vegetation complexity and abundance, and improved fish habitat associated with increased depth, turbulence, and structural cover.

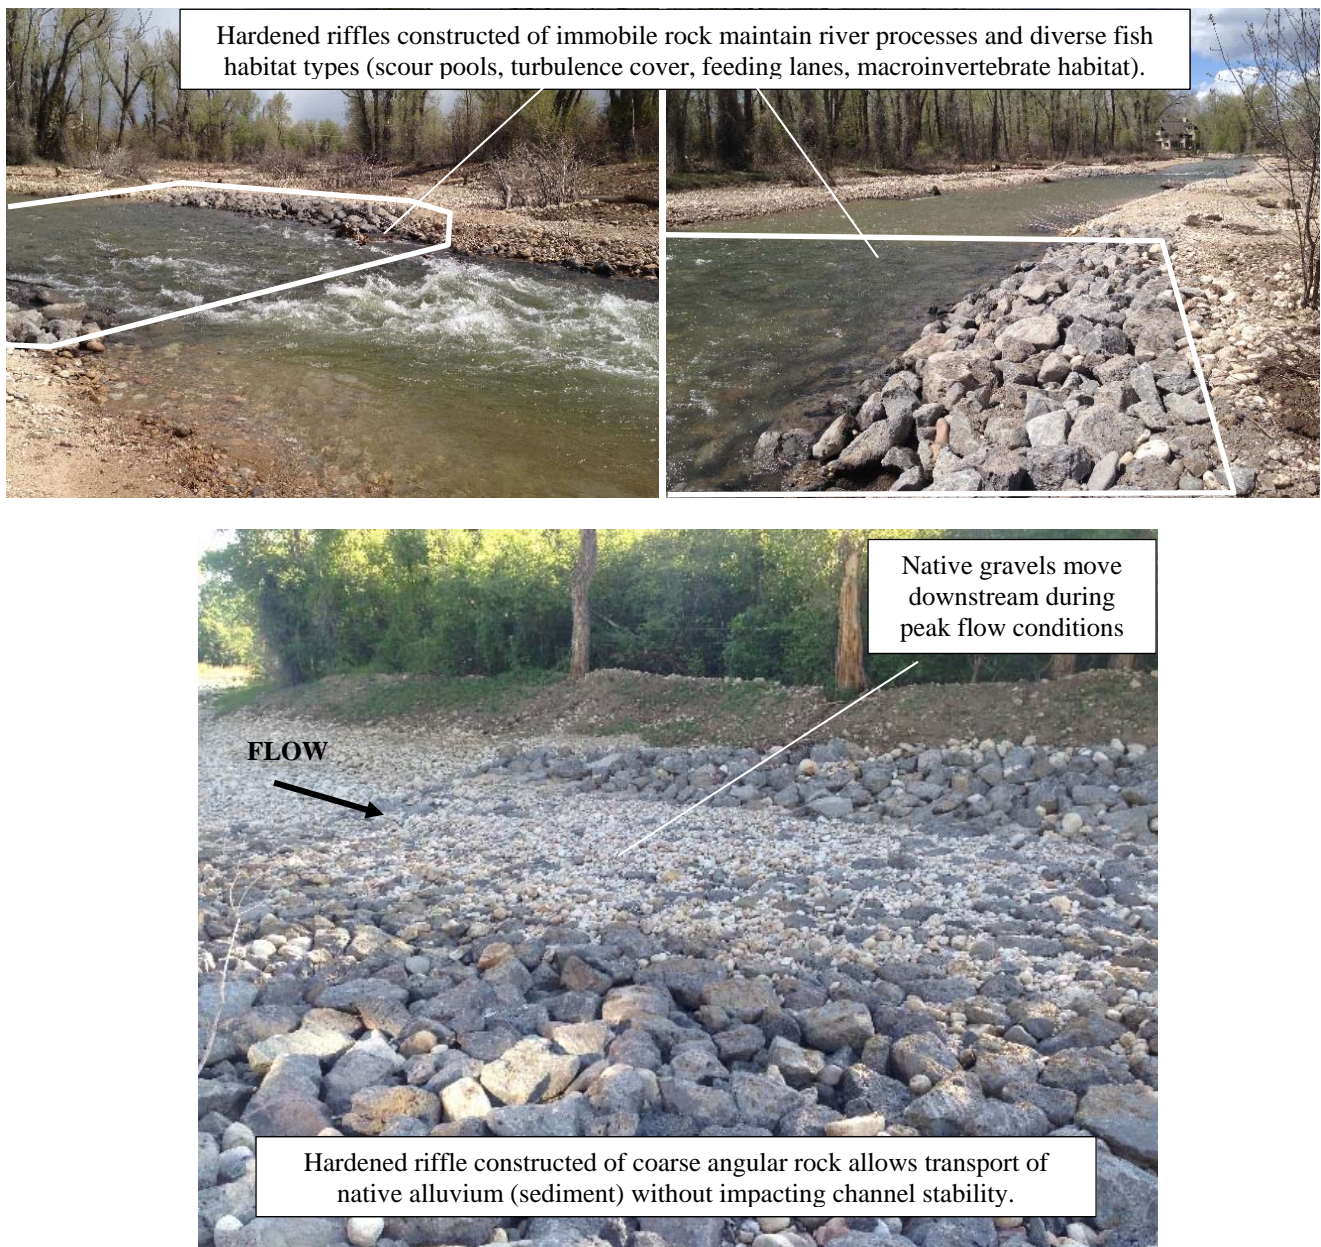
Figure 56. Hardened riffles maintain vertical channel stability and establish design channel width while maintaining downstream scour pools (top left and right). The hardened riffle treatment enables conveyance of native alluvium (sediment transport) while maintaining channel stability using moderately sized rock (bottom).

The hardened riffle treatment does not incorporate large boulders, but utilizes moderately sized rock to achieve vertical channel stability. The treatment maintains long riffle bed features, downstream scour pools for energy dissipation, and depth and turbulence cover for fish habitat. The hardened riffle treatment is depicted visually in Figure 56 from work previously completed within Teton Creek, and in Figures 57 and 58 from projects recently completed in the region.

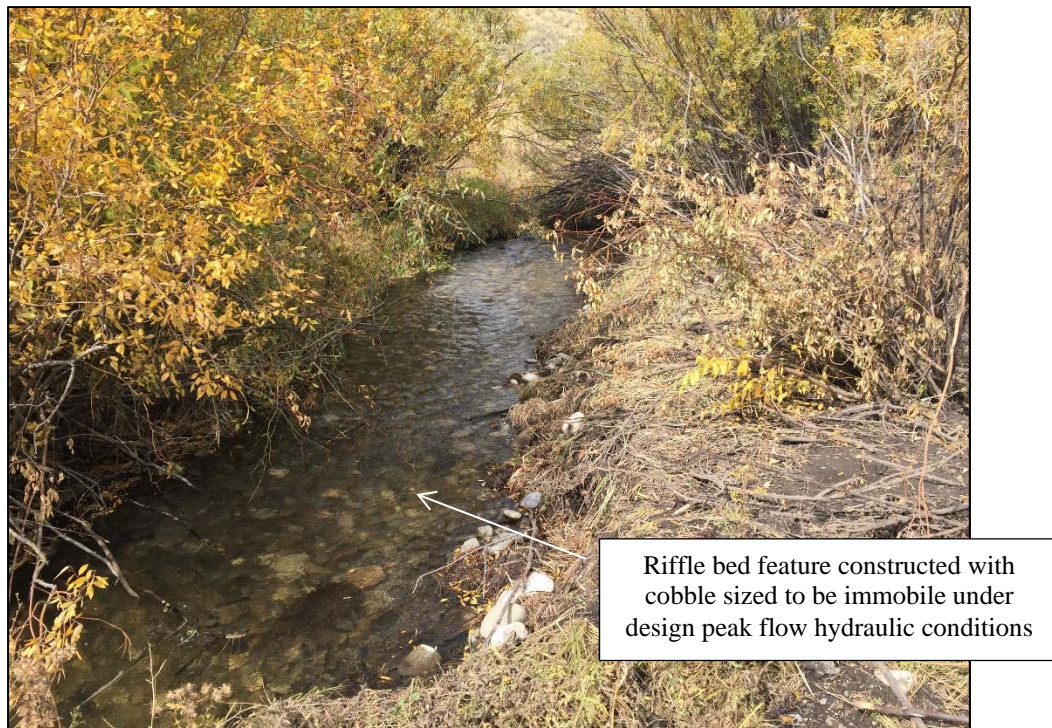
Figure 57. Photograph of installed hardened riffle grade control treatment.

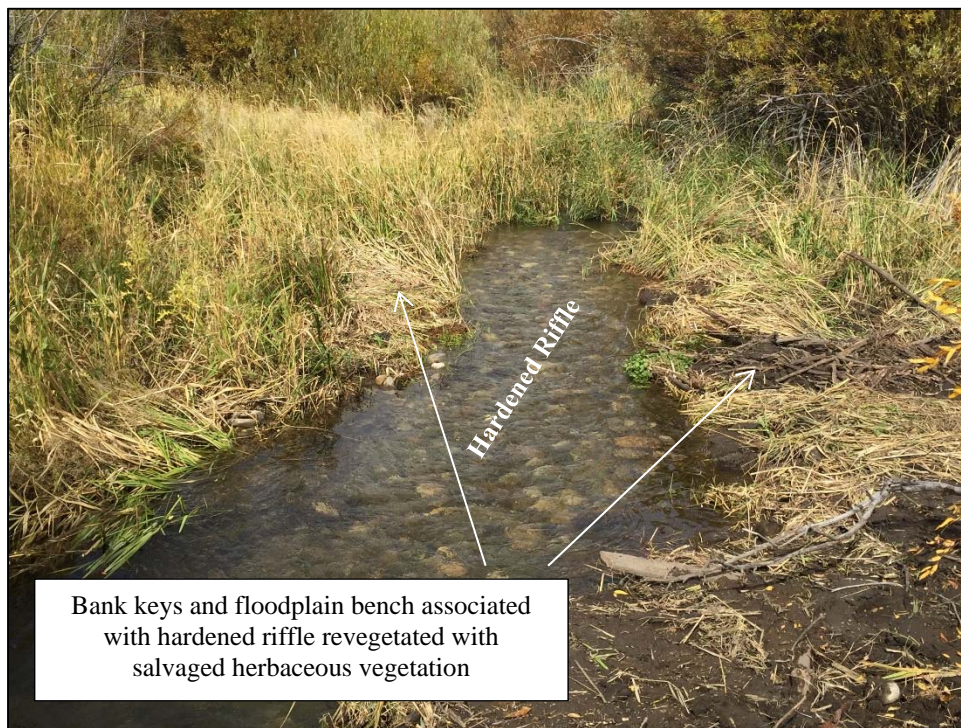
Figure 58. Photograph of installed hardened riffle grade control treatment.

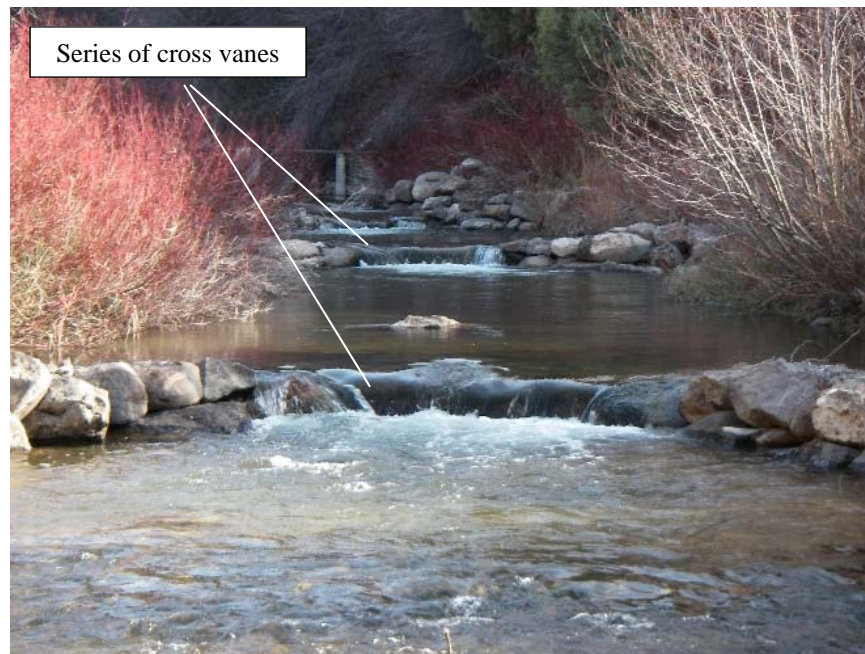
Figure 59. A series of rock cross vanes (top) distributes excessive local gradient while enabling sediment transport and maintaining downstream pools and mid-channel turbulence cover for fish habitat. A single large rock cross vane (bottom) maintains grade control and channel width while consolidating low flows in the center of the channel for hydraulic and fisheries benefits.

The rock cross vane treatment can also be used to accomplish grade control, but this treatment alternative is less desirable than the hardened riffle because cross vanes are susceptible to failure (if individual boulders are undermined or mobilized) and vanes promote artificially short drops with plunge pools instead of more natural lengthy riffles with scour pools. However, rock cross vanes are preferable to traditional rock sills that extend straight across the river channel because vanes consolidate flows in the

center of the channel in order to maximize sediment transport and downstream scour. The treatment is depicted visually in Figure 59 from a project recently completed in the region.

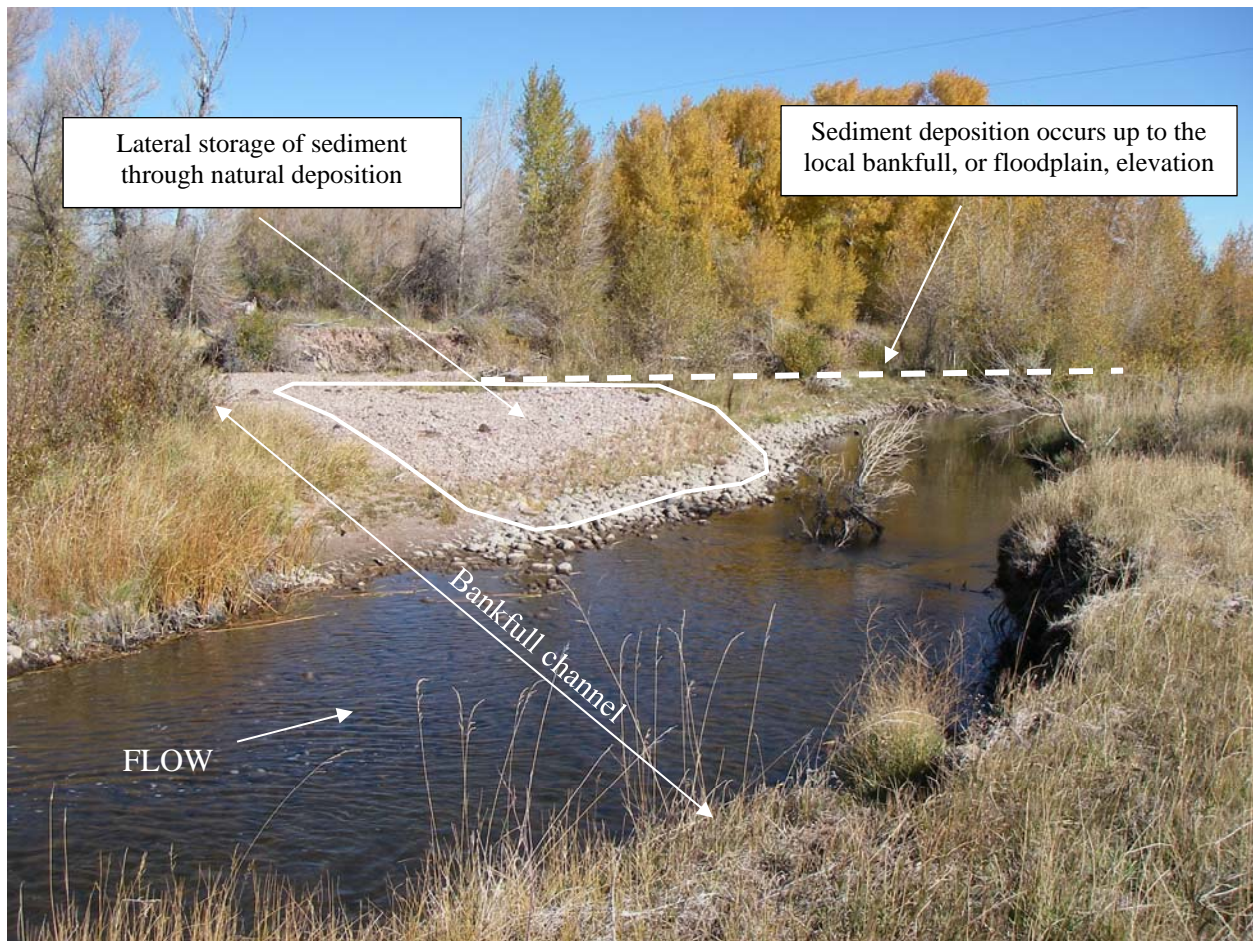
Figure 60. A photograph depicting a lateral storage facility.

Sediment storage facilities in the Assessment Reach of Teton Creek could consist of lateral storage areas that are appropriate within relatively straight sections of channel. A lateral storage area (exemplified in Figure 60) consists of a defined gap in the stream bank that is hydraulically connected to the bankfull channel and enables for the deposition of bedload during peak flow events. Lateral storage areas can be located in areas where adequate equipment access provides for the economical removal of sediment from storage facilities as needed, in order to provide long-term sediment storage functionality.
